A SUSTAINABLE AND INTEGRATED BUILDING RENOVATION

A United Nations Earthquake Recovery Initiative in Chile

Published February 2015

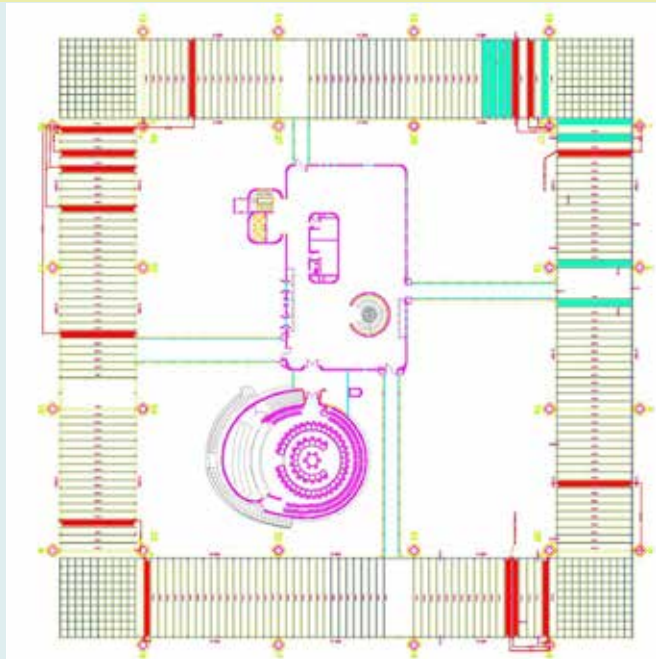
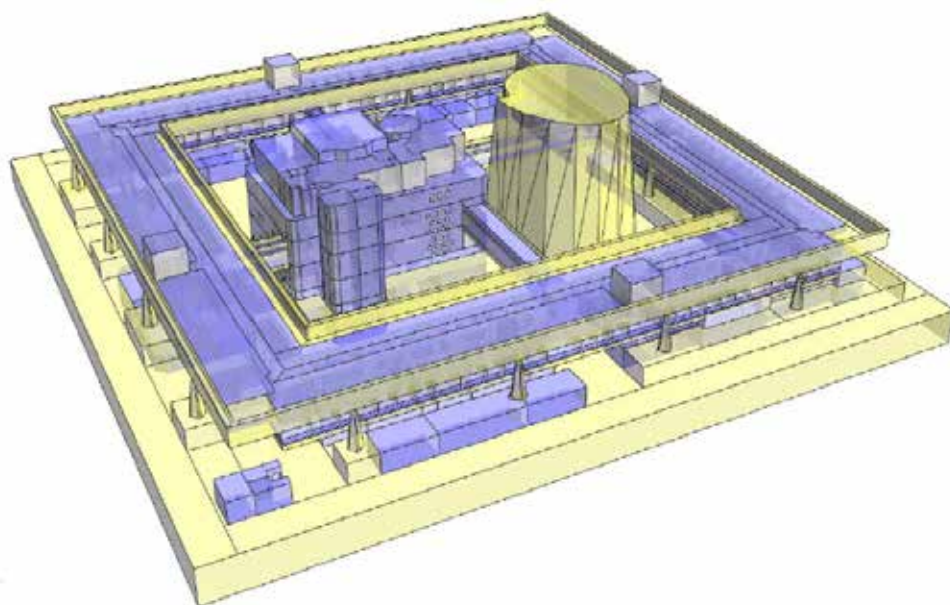
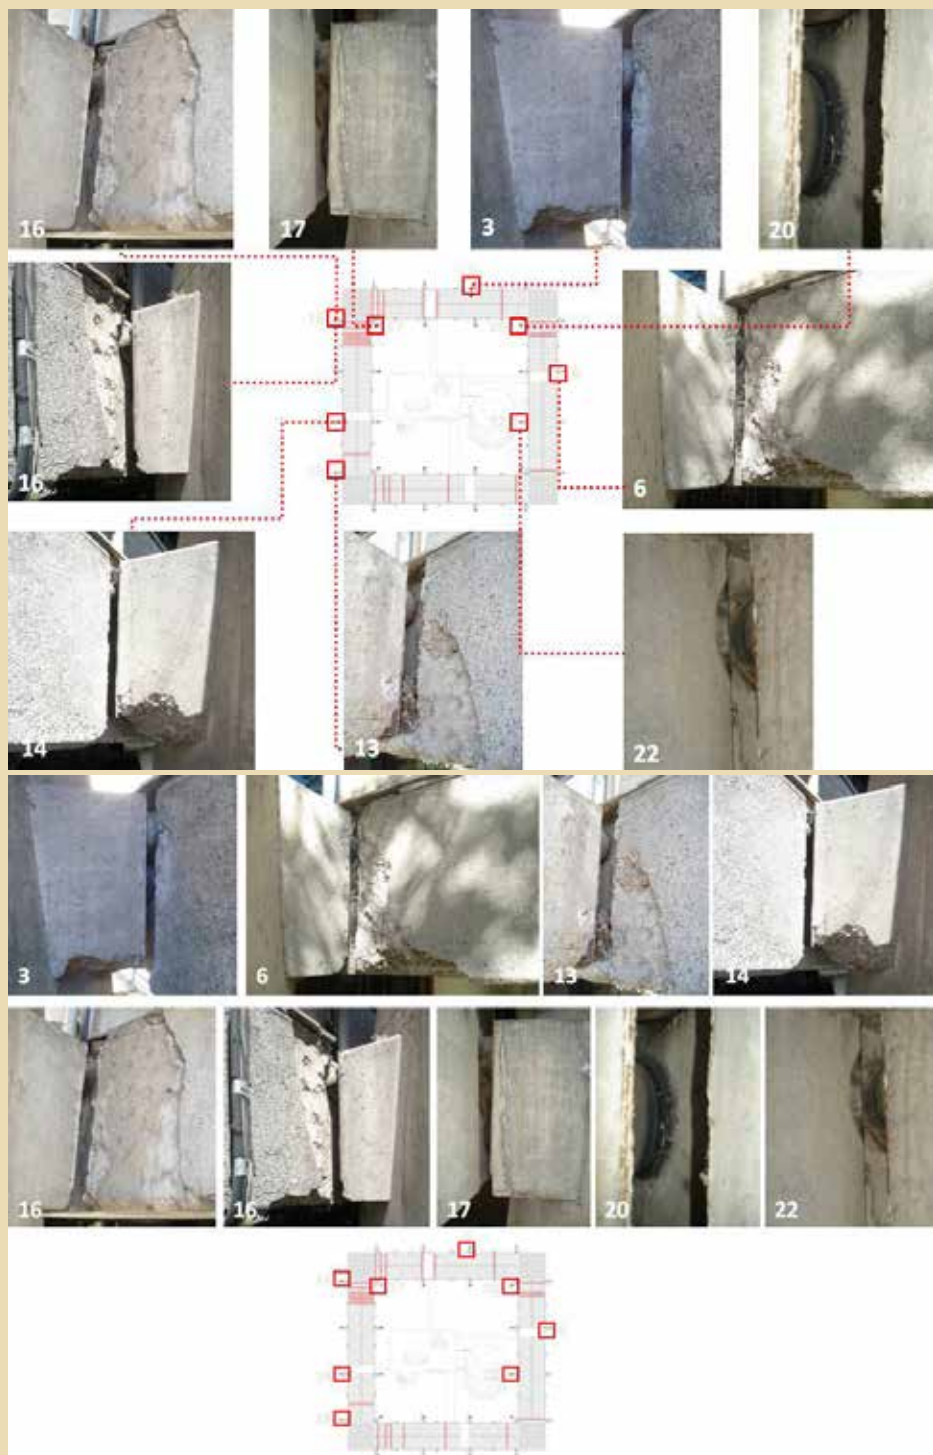
After the earthquake an initial visual building evaluation considered a potential structural failure due to material stressed to its strength limit, attributable to visible fracture and deformations of reinforced concrete and steel structures. Afterwards three independent structural reports were requested; various types of failures were observed in the structural inspection and a general structural failure was discarded. Failures that do not compromise the overall condition of the building were identified as follows: main structural components– fractures including staircases, columns, main beams and slabs; displacement of hanging structures which accommodate main office space of the Commission; structural failure of connecting bridges' fasteners and bumpers; structural steel bar fatigue; buildings' envelope damages including fracture and collapse of steel and aluminum façade frames, numerous broken windows. In addition ECLAC's main building presented extensive interior damages including but not limited to: collapse of ceiling structure and ceiling tiles; office partitions system collapse and/or damage due to torsion of main structural frames; floor coverings damage due to flooding caused by piping breakage. Several subsystems were damaged resulting in: lighting fixtures collapse; access control system PACT equipment failure. Finally, mechanical systems resulted with damage as a result of water, HVAC ducts, and gas piping breakage.

Structural Fissures: Main Building slabs presented structural fissures in multiple locations. These cracks are caused during concrete curing when shrinkage exists and later were amplified with the earthquake; in areas in where reinforcing bars are overlapped the appearance of these cracks is much lower (for reference see images).

Structural Displacements: Some of the structural columns showed displacements with values of 8-12 mm from the west to the east and 4-8 mm from the north to the south (data according survey report). Displacements are due to structural design since these columns are of the sliding type; the above implies that due to the earthquake the building was left with a residual deformation at these points.

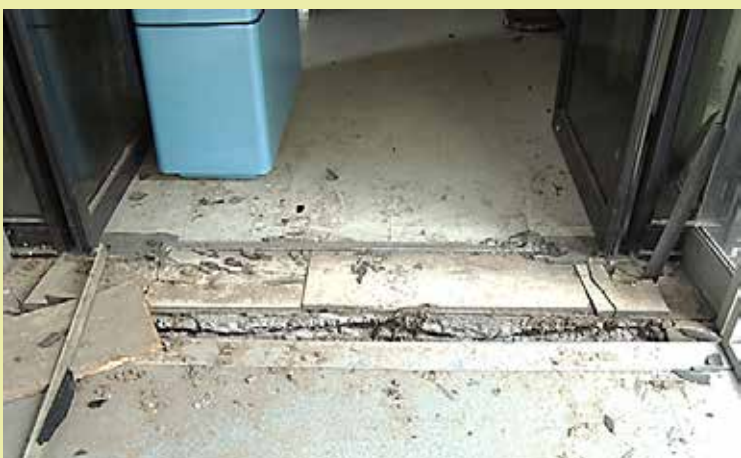
Connecting Bridge Fasteners: Reinforced concrete expansion fasteners included rubber bumper absorbers and were located in each of the four connecting bridges which provide access to the main floor. All of these sustained severe damages due to the slab's excessive oscillation and its correspondent impact on these elements. Far from the bridges' total collapse as happened in previous seismic events, the connecting bridges remained in place, even though due to inadequate anchoring and poor adherence the fasteners failed and resulted with severe displacement and consequential damage.

Perimeter Beams Minor Fissures: Several cracks were noticed and inspected in post-tensioned concrete perimeter beams. These damages were especially visible in those beams which run from the north to south axis due to seismic movement of west to east—perpendicular to the beams' major axis.

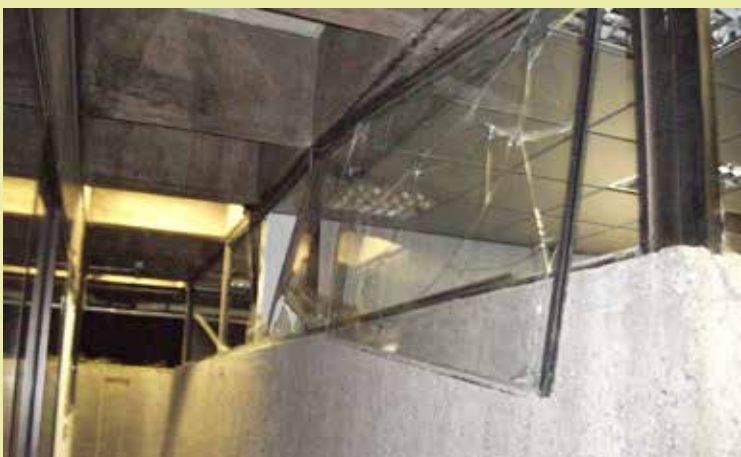
Failure of Glazing Structures: Similarly, there was damage to the metallic frames holding windows due to the lack of adequate space and expansion joints—crevices and chinks occurred.

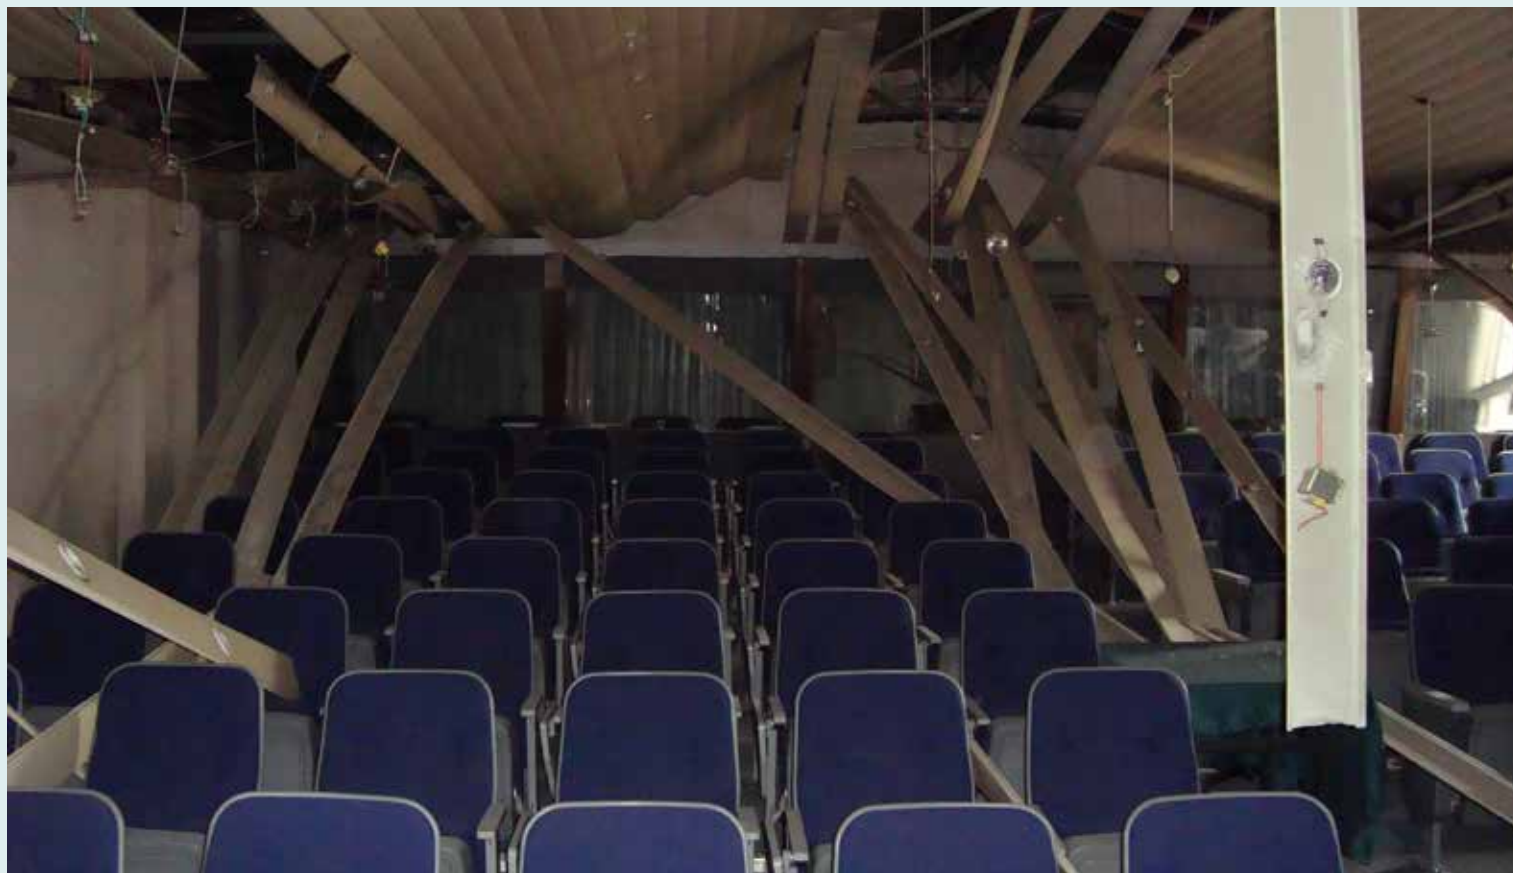
Fourth Floor Fajnzylber Auditorium: Built as an extension on the third floor covering the roof of the amphitheater, the Auditorium suffered severe damage on both its ends and in the raised steel structure, which is considered inadequate as a seismic behavior. An independent structural report was requested and various failures types were observed in the structure, not compromising lower floors. Such failures include:

- Partition walls with large fissures in several sectors due to excessive deformation;
- False ceiling system collapse leaving most of the conference room covered in debris;
- Possible structural damage in several components (evaluation consisted of limited visual inspection– later after demolition serious structural damages were confirmed);
- Possible failures of structural column joints due to large displacements (limited by visual inspection– afterwards structural damage to columns was verified).

According to the structural report, complete structure demolition and replacement was indicated due to the lack of rigidity against lateral movement.

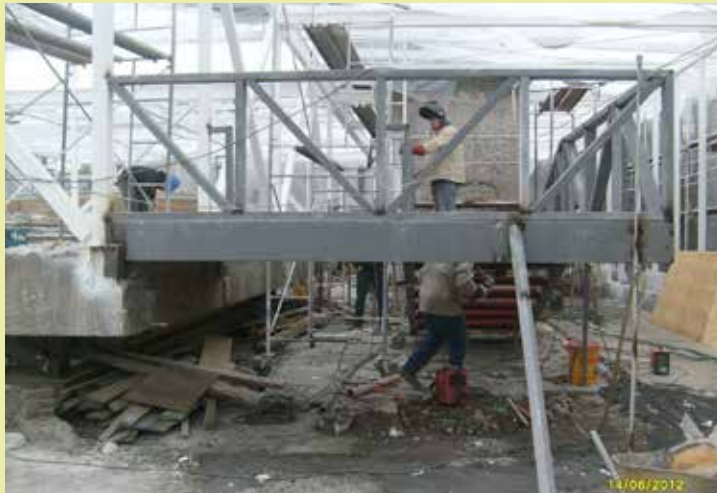
DEMOLITION PROCESS

The conference room on the fourth floor suffered major structural damage during the 2010 earthquake, making necessary its complete demolition and reconstruction.
