Assessment  
of the Effects and Impacts of  
**HURRICANE DORIAN**  
in **THE BAHAMAS**

Assessment  
of the Effects and Impacts of  
**HURRICANE DORIAN** in  
**THE BAHAMAS**

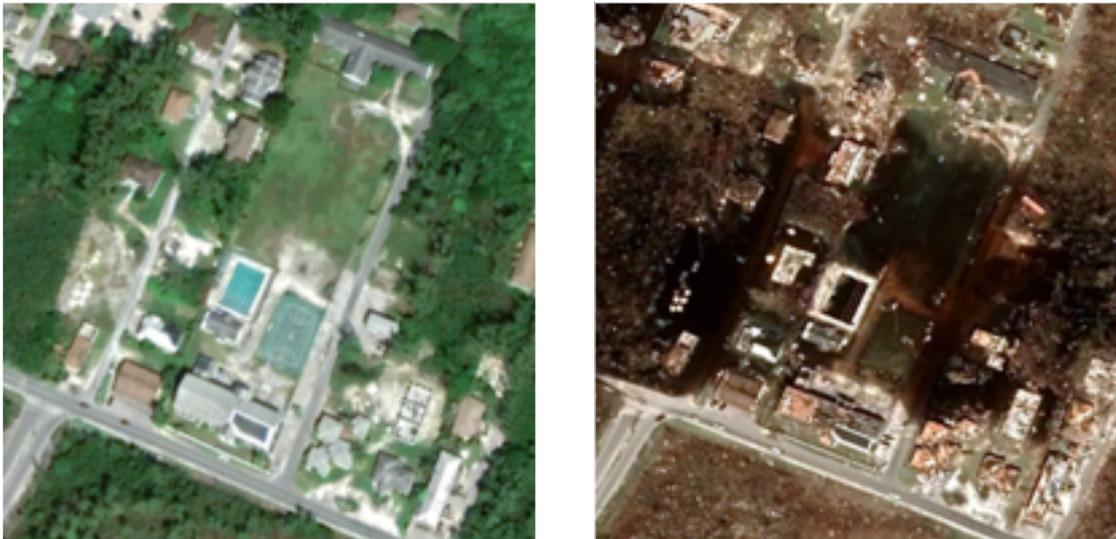
FIGURE 17. BEFORE AND AFTER IMAGES OF THE DAMAGE AT ABACO CENTRAL PRIMARY SCHOOL

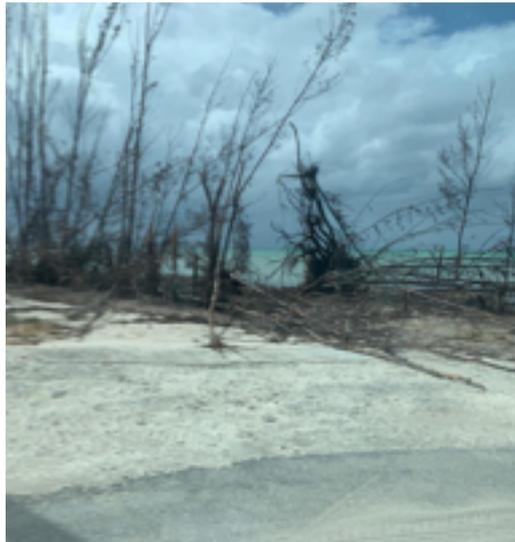
FIGURE 18. ROAD CLOSE TO SHORELINE

The damage to the roads can be categorized in two different forms. First, structural damage to the asphalt layer or the granular base was observed and requires repair. Secondly, operational damage was observed, where the road access was interrupted for a limited time due to the level of water (light vehicles cannot pass through) but without immediate structural deterioration. The second case may have an indirect effect in the road durability produced by water saturation of the granular layers and potential loss of material, but the potential costs of which are not considered in this study. Table 38 summarizes only the estimated structural damage associated to the roads on both islands. Notice that approximately 80 percent of this damage took place on Abaco.

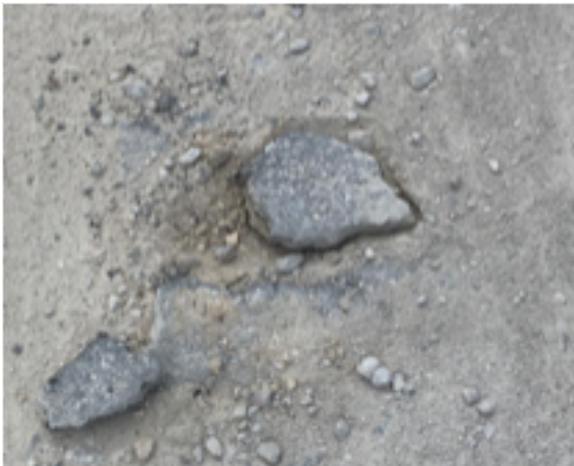
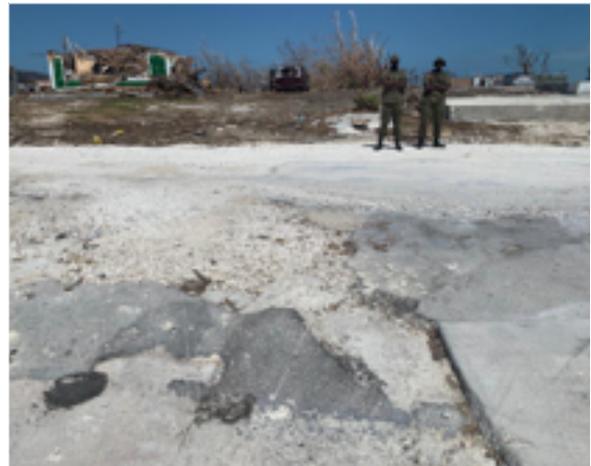
FIGURE 19. DEFICIENT ASPHALT MIXES

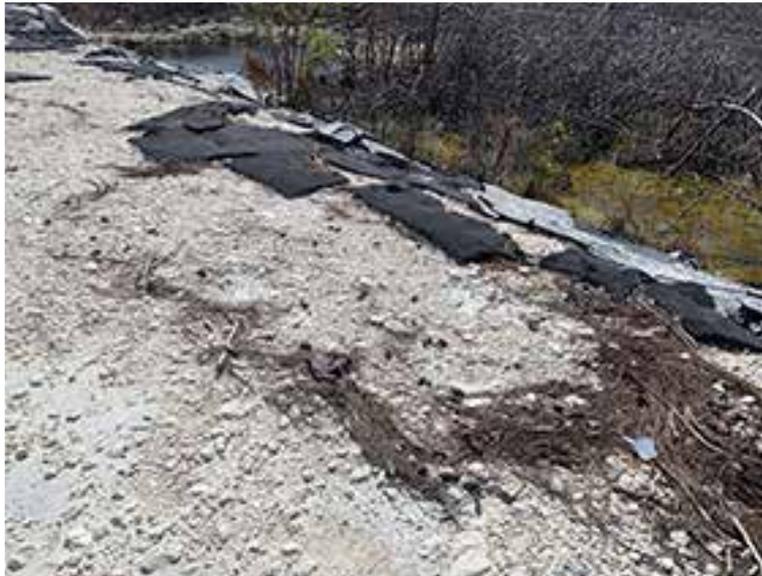
FIGURE 20. LACK OF TACK COAT AND NOT UNIFORM GRANULAR SUBBASE

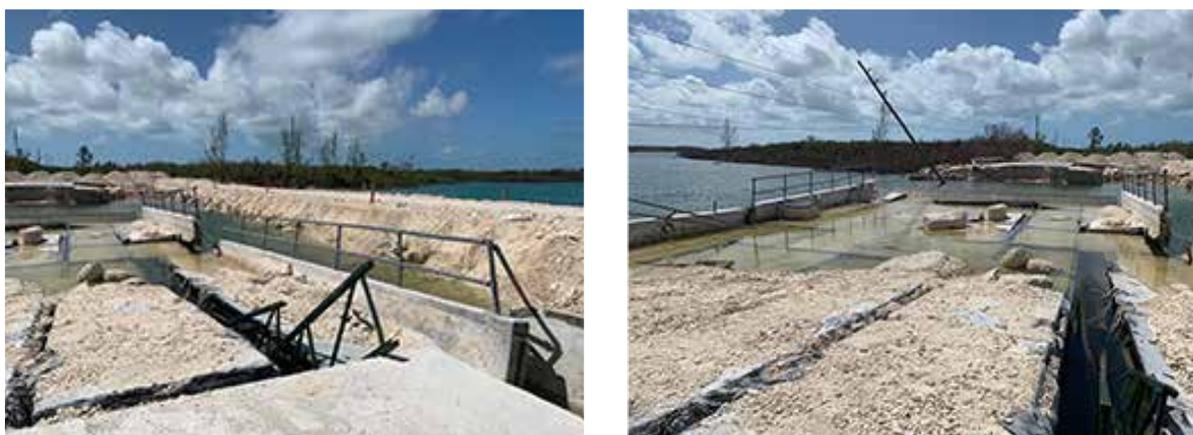
FIGURE 21. COLLAPSED BRIDGE IN NORTH ABACO

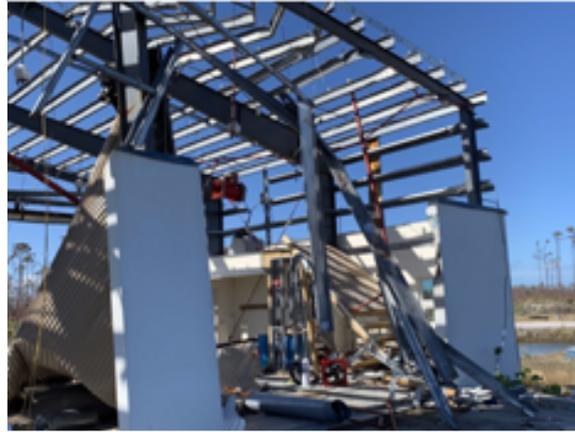
FIGURE 22. AIRPORT HANGARS DAMAGED IN MARSH HARBOUR

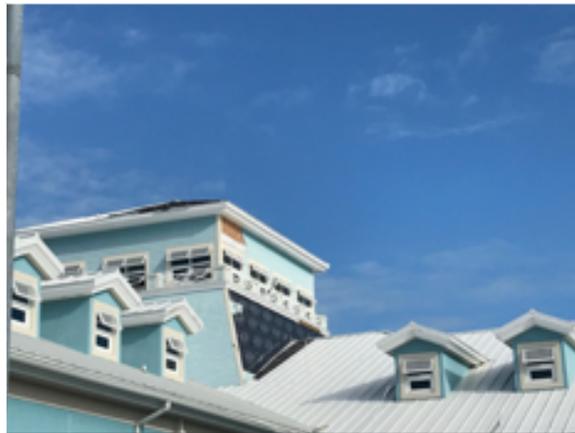
FIGURE 23. ROOF DAMAGE IN MARSH HARBOUR INTERNATIONAL AIRPORT

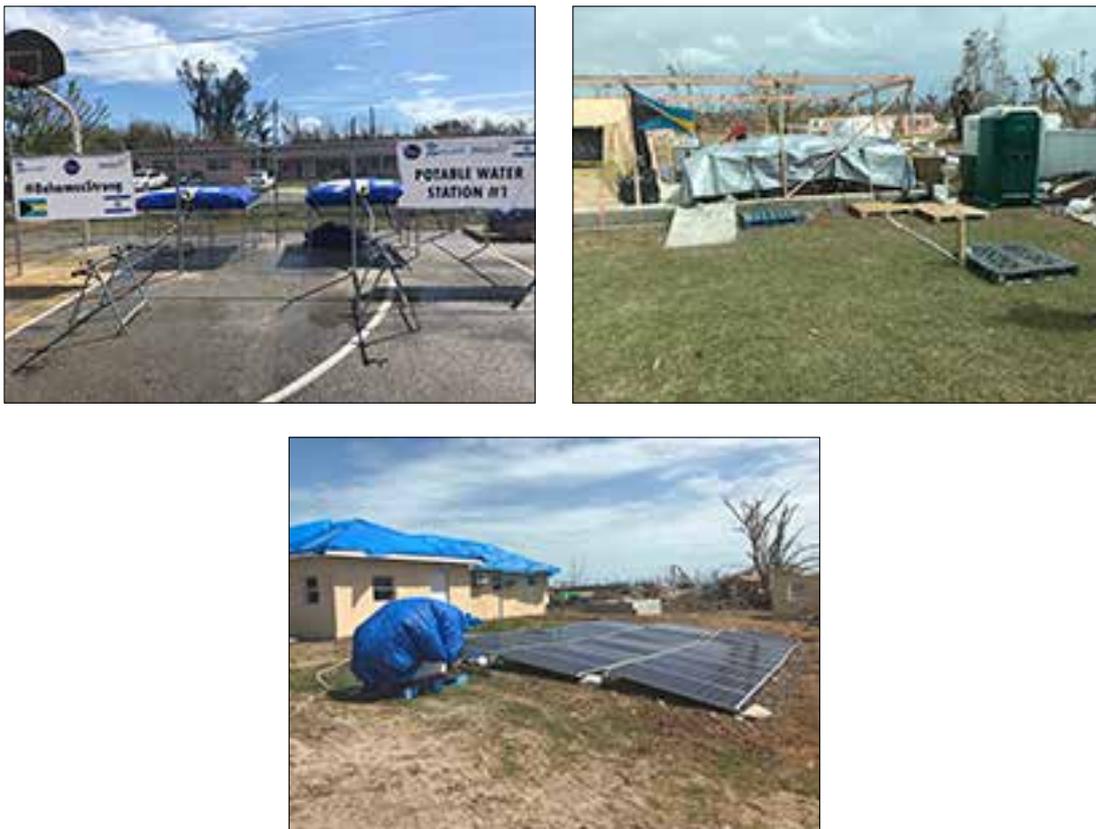
FIGURE 24. RO PLANTS AND WATER DISTRIBUTION SYSTEMS

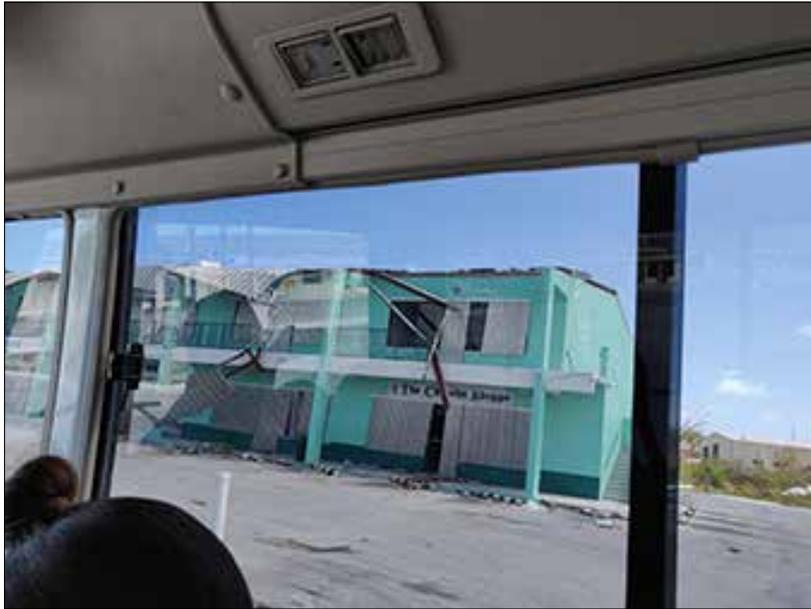
FIGURE 27. DAMAGE IN NON-STRUCTURAL ELEMENTS

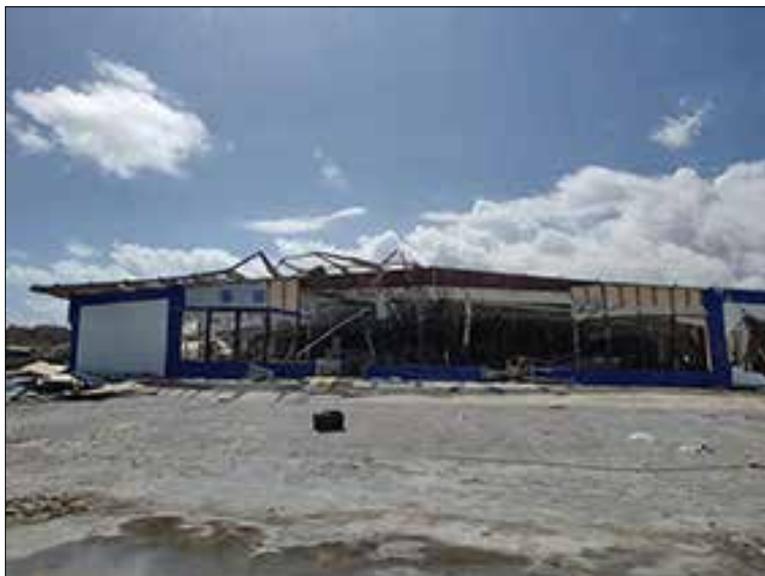
The high exposure of some structures exacerbated the damage. Many structures close to the coastline were exposed to greater solicitations and consequently had greater structural damage. Figure 28 shows that a Standard Hardware company facility suffered structural damage to its walls and ceiling. Structures like hangars with low resistance cladding and large walls were highly affected by hurricane winds. In sum, inadequate building codes and building materials, and the location of the structure, were the main causes of damage.

FIGURE 28. DAMAGE CAUSED BY WIND FORCE

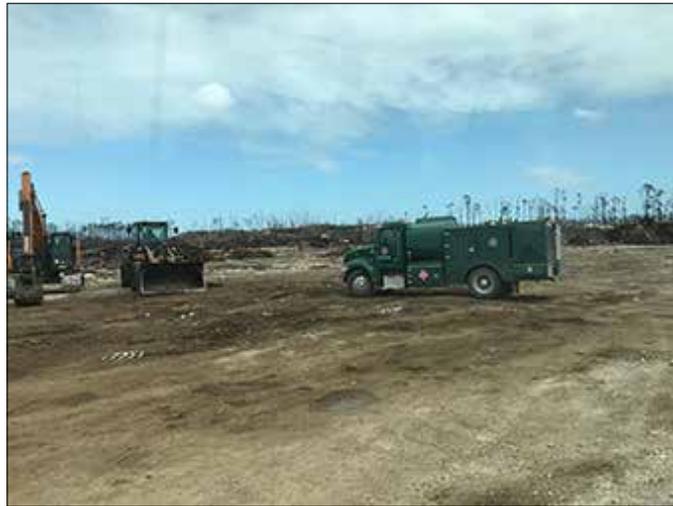
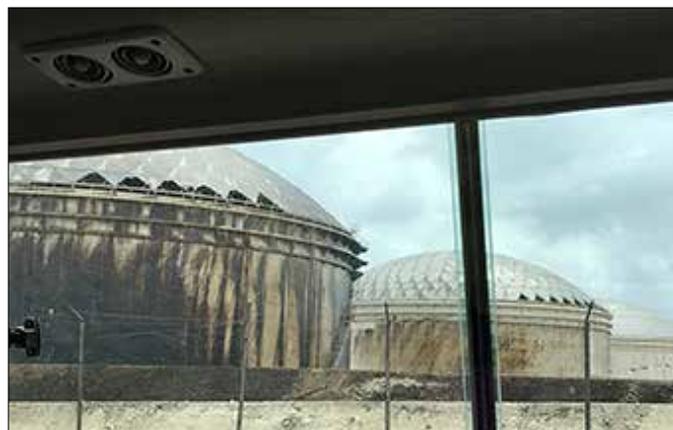
FIGURE 37. GRAND BAHAMA - OIL SPILL AT EQUINOR SOUTH RIDING OIL TERMINAL

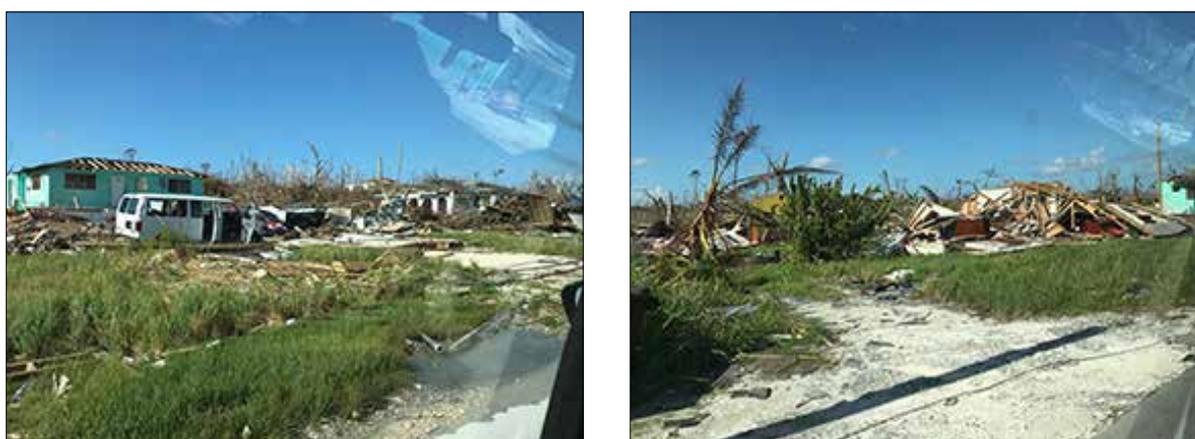
FIGURE 45. HOUSES (STRUCTURE / ROOF) BUILT IN WOOD

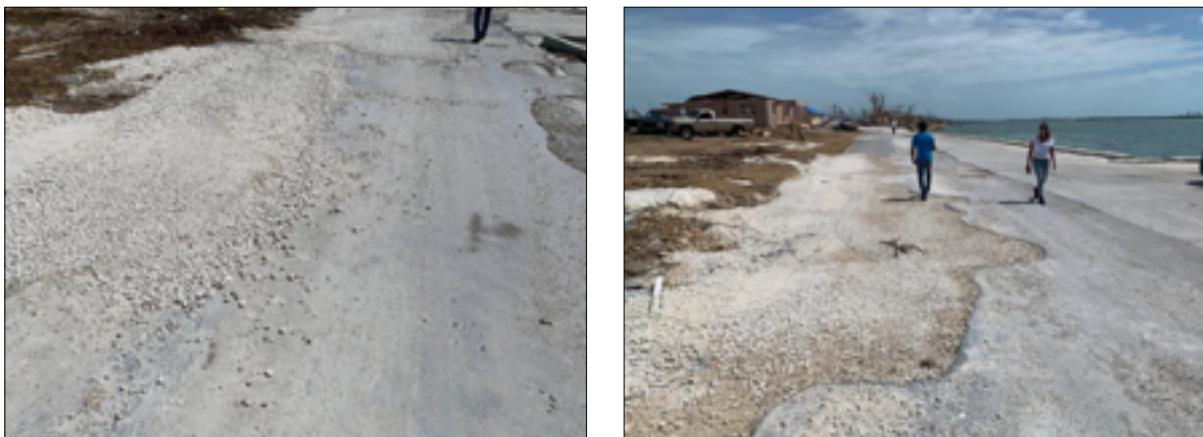
FIGURE 46. DAMAGED ROAD ON GRAND BAHAMAS ISLAND

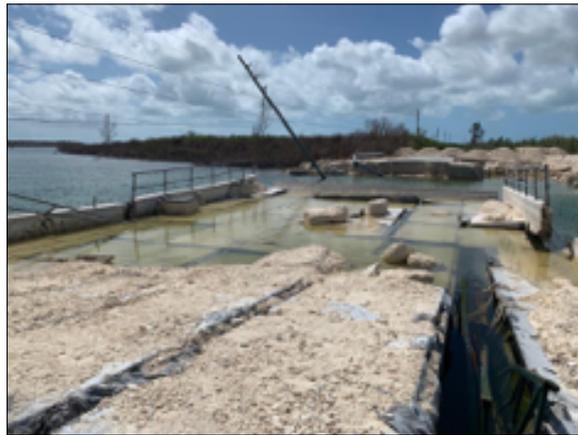
FIGURE 48. COLLAPSED BRIDGE IN NORTH ABACO

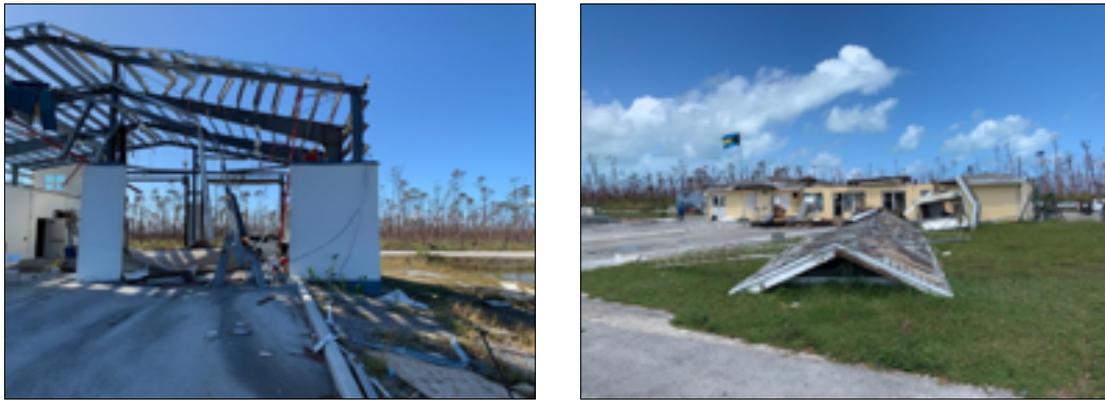
FIGURE 49. STRUCTURAL DAMAGE IN THE AIRPORT ON ABACO

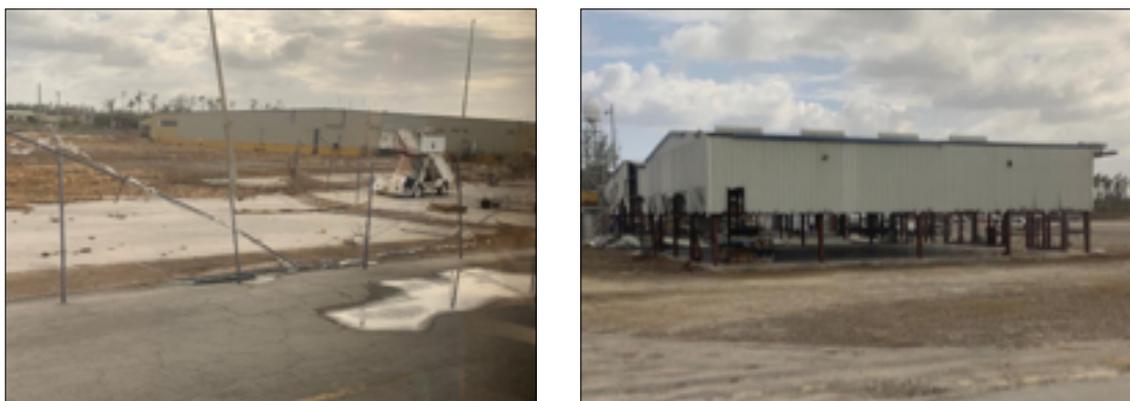
FIGURE 50. DAMAGE TO NON-STRUCTURAL ELEMENTS IN FREEPORT INTERNATIONAL AIRPORT

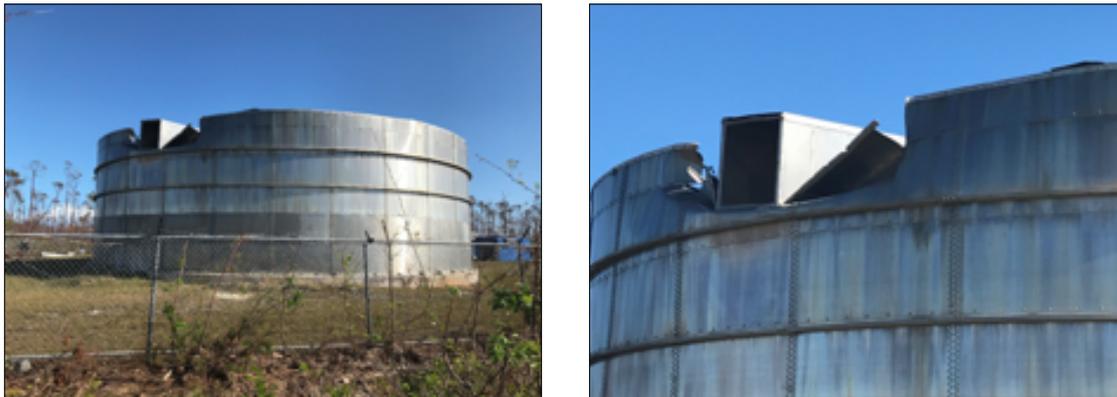
FIGURE 52. MAIN STORAGE TANK DAMAGE IN MARSH HARBOUR PUMP STATION

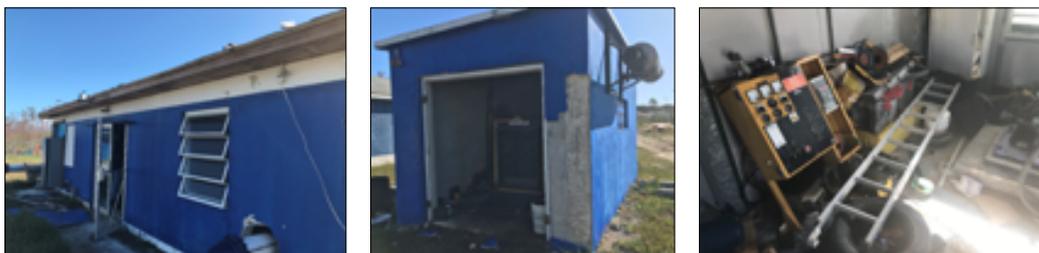
FIGURE 53. DAMAGE TO PUMP STATIONS IN MARSH HARBOUR AND TREASURE KEY

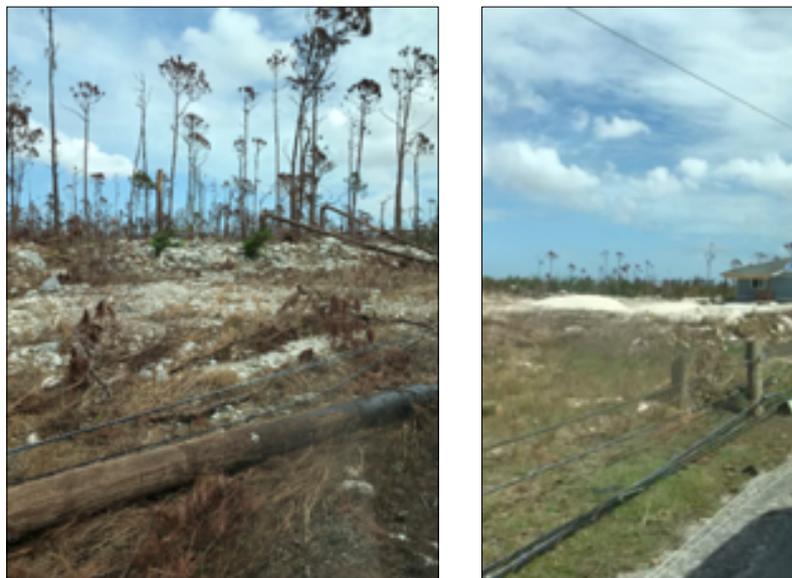
FIGURE 54. POWER DISTRIBUTION NETWORKS ON GRAND BAHAMA (VIA EAST END)

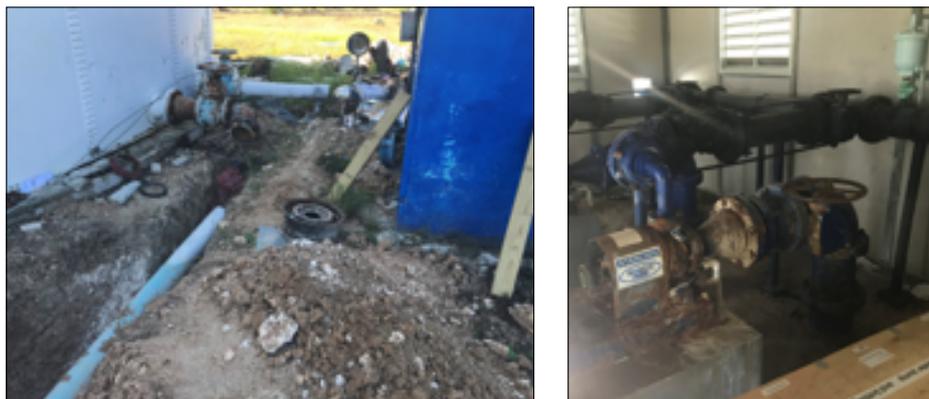
FIGURE 57. PIPING SYSTEMS / PUMPING SYSTEMS

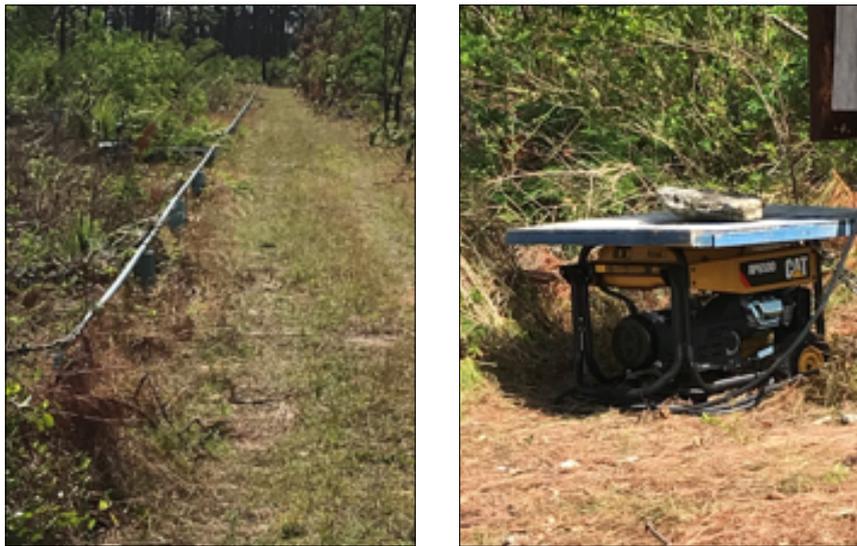
FIGURE 58. GROUND WATER COLLECTION SYSTEM / POWER BACK UP

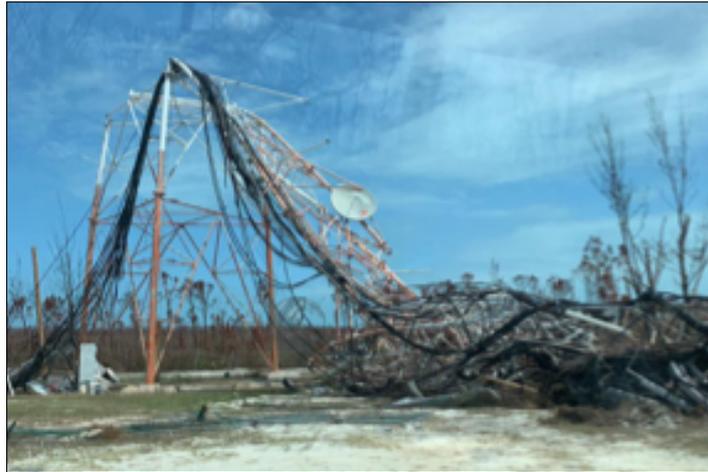
FIGURE 59. FALLEN CELLULAR TOWER, WITH DESTROYED BASE TRANSCIEVER STATION

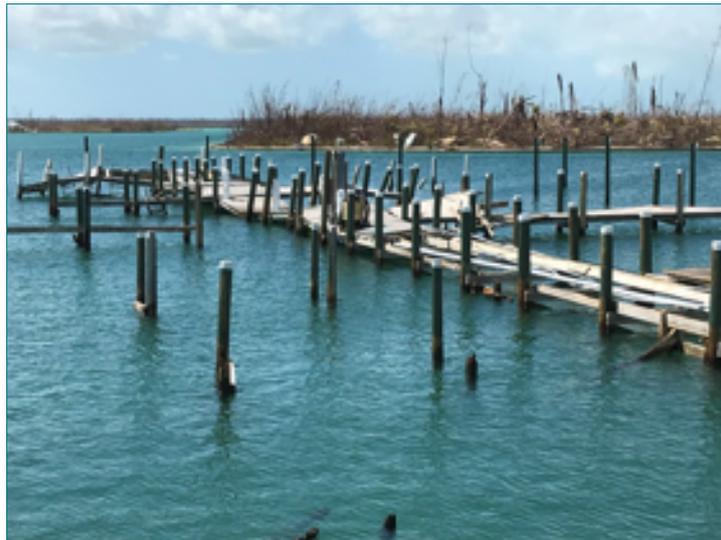
FIGURE 60. DAMAGED RECREATIONAL DOCK

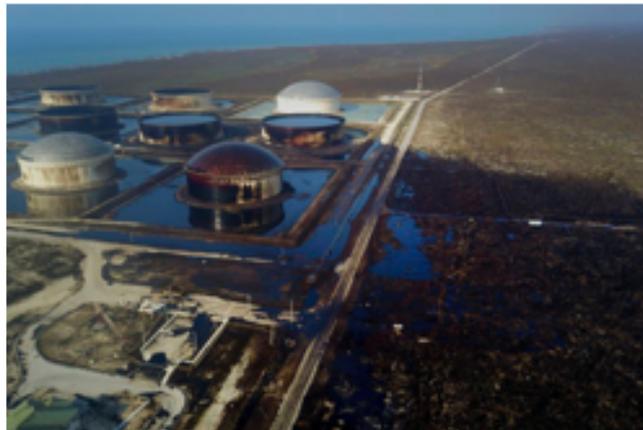
FIGURE 61. SPILL AT SOUTH RIDING POINT OIL STORAGE FACILITY GRAND BAHAMA

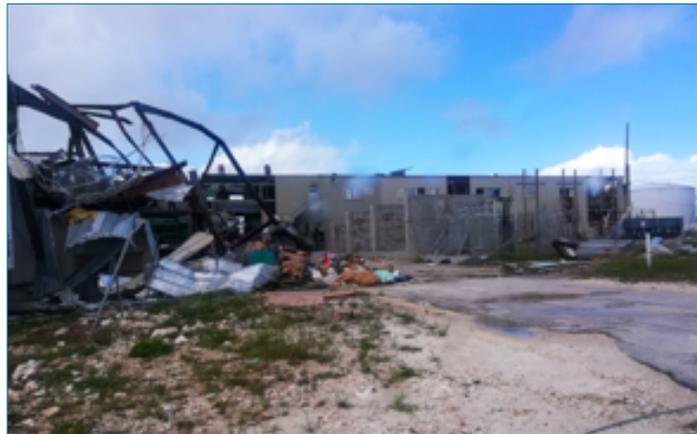
FIGURE 62. SEVERELY DAMAGED POWER PLANT AT MARSH HARBOUR
