GUYANA

SOCIO-ECONOMIC ASSESSMENT OF THE DAMAGES AND LOSSES CAUSED BY THE JANUARY-FEBRUARY 2005 FLOODING¹

In collaboration with the Inter-American Institute for Cooperation on Agriculture (IICA)

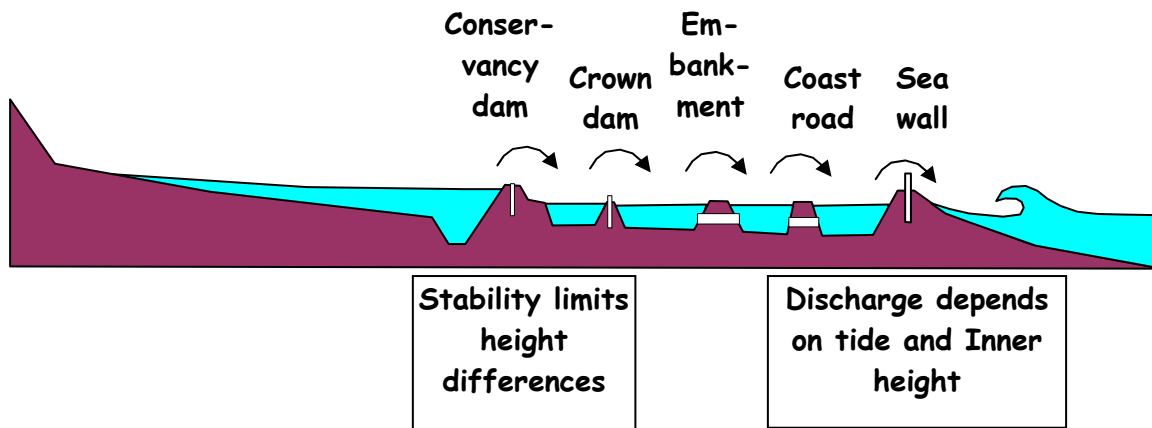
Figure 2 Cross-section through area of main habitation

The combination of agriculture and habitation has been facilitated on this low-lying coastal plain by the presence of a well-designed system of reclaimed lands, drainage and irrigation canals, conservancy dams and seawalls. A cross-section on a north-south plane is shown in Figure 2 below³

North of the Conservancy Dam, a Crown Dam was constructed (see Figure 2 above), primarily to ensure proper retention of irrigation water in the agricultural areas. It is not believed that this structure was built with the intention of being a second line of defense for the coastal areas against flood waters. Working as a part of this overall and complex hydraulic system, is a series of sluice gates, or kokers, and pumping stations, which are to be found along the coastal sea wall, and which serve to ensure the proper drainage of the coastal lands immediately adjacent to the sea. Again, over the years a number of these installations have become derelict and unusable, thereby significantly exacerbating the potential for localized flooding within this zone (see Photos 1 and 2 below). In all, it is estimated that at least six such installations will need to be rehabilitated, in order to regain the utility of this aspect of the drainage system.

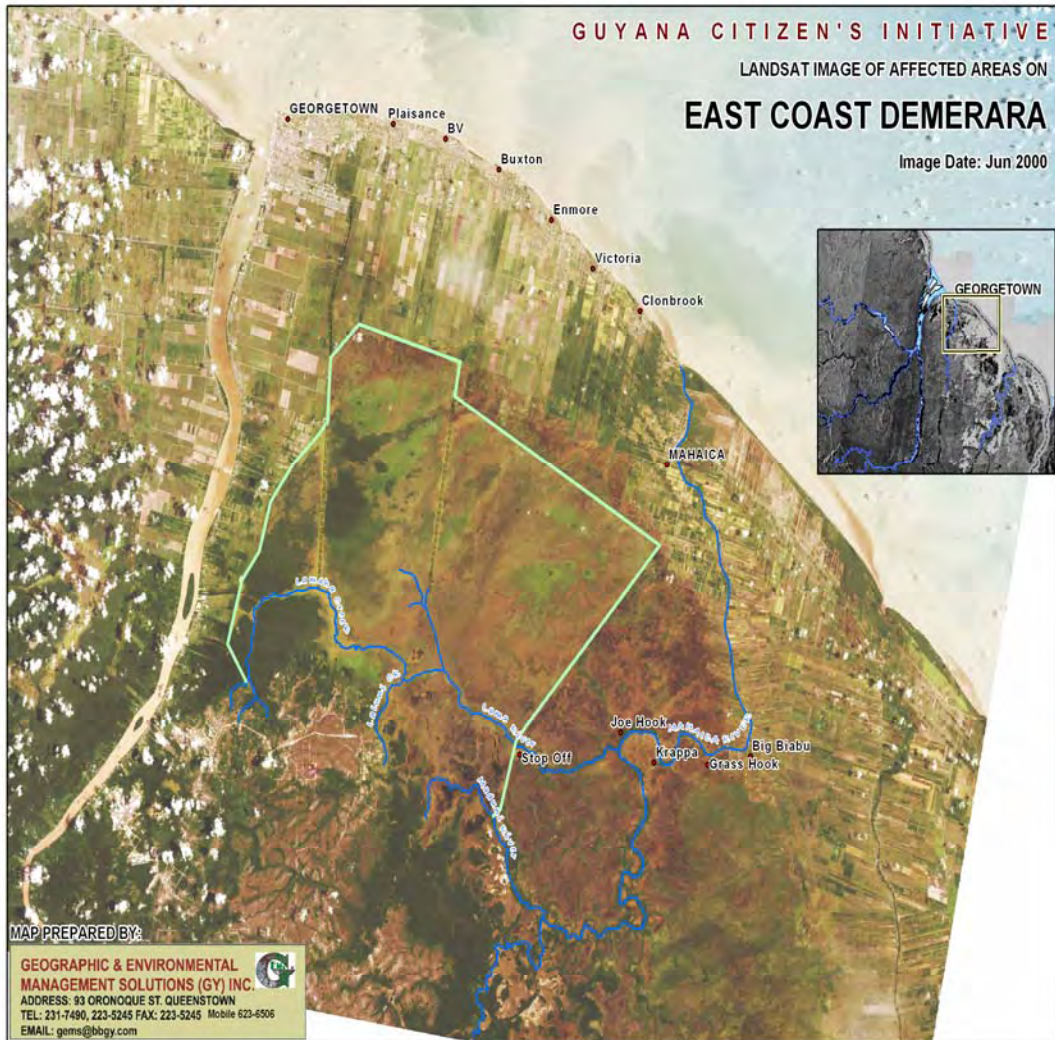
Figure 3 **Satellite image of affected area**

In effect, discharge to the Demerara River is now primarily through a structure at the town of Land of Canaan, known as '5 Gates', which is one of four structures that originally facilitated discharge to that river. On the eastern side, there are three operational structures that facilitate discharge to the Mahaica River, although opening of these structures usually results in flooding of towns along this river. In addition to these four functioning discharge structures, there are two canals that discharge directly to the Atlantic Ocean, Shanks and Nebaclis. These canals also require dredging and repairs to culverts and outlet structures, in order to restore them to their former efficiency. Figure 3 below presents a satellite image of the area in question.

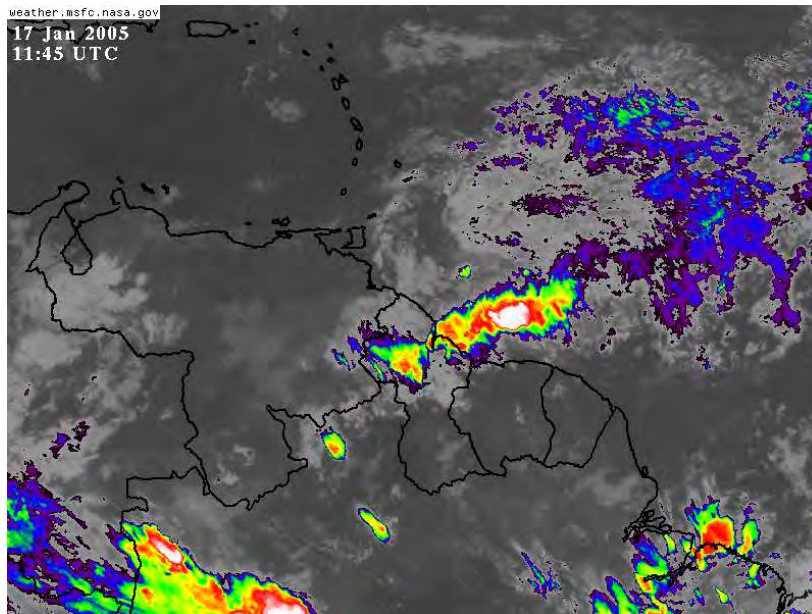
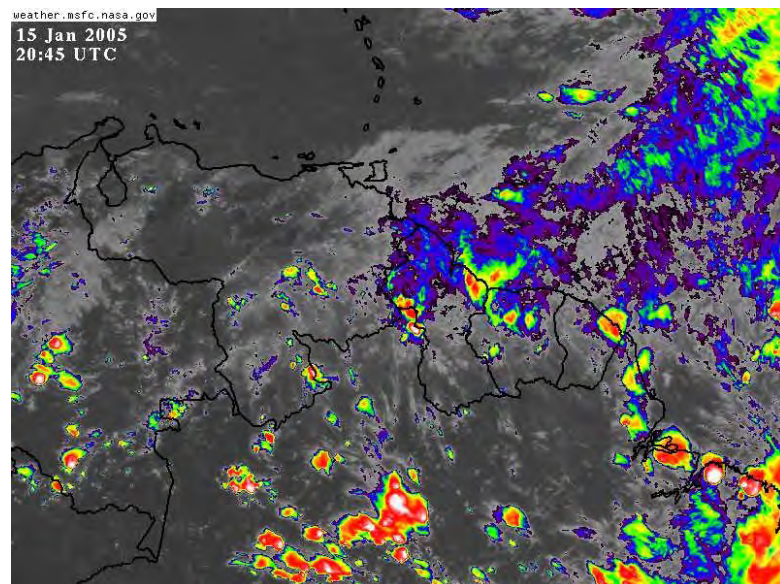
Figures 4 (above) and 5 (below) Satellite Images of Guyana

From 14-22 January, however, the coastal regions of Guyana received some of the heaviest rainfall on record since 1888. These rains were, interestingly, not associated with the usual weather systems affecting Guyana, but rather with influences from the southern hemisphere. This was an anomalous condition, as these southern hemisphere systems usually only exert influence over the southern part of Guyana. This raises the issue of changing weather patterns that must be taken into account when long-term developmental plans are being made. Satellite infra-red images on two of the days of heavy rain are shown in Figures 4 and 5 below.

Weather conditions over Guyana for this period of heavy rainfall were characterized by an unusual flow of winds from the west to the east. This flow interacted with higher level winds to form a zone of instability above the northern part of Guyana. Moisture laden clouds from the Amazonia region were therefore swept by these winds over the coastal areas of Guyana, resulting in excessive rainfall. This rainfall was so intense that it established new records at the Botanical Gardens, Georgetown, for two, three, four and five-day rainfall, all between 14-18 January. In addition, the monthly rainfall for January 2005 has now become the new maximum monthly rainfall record (1108.2 mm or 43.6 in). It should be noted that these records are in reference to the start of record keeping in 1888. Prior to this event, the highest monthly record at this station was for the month of December 1942, when 1022 mm, or 40.2 in. were recorded.

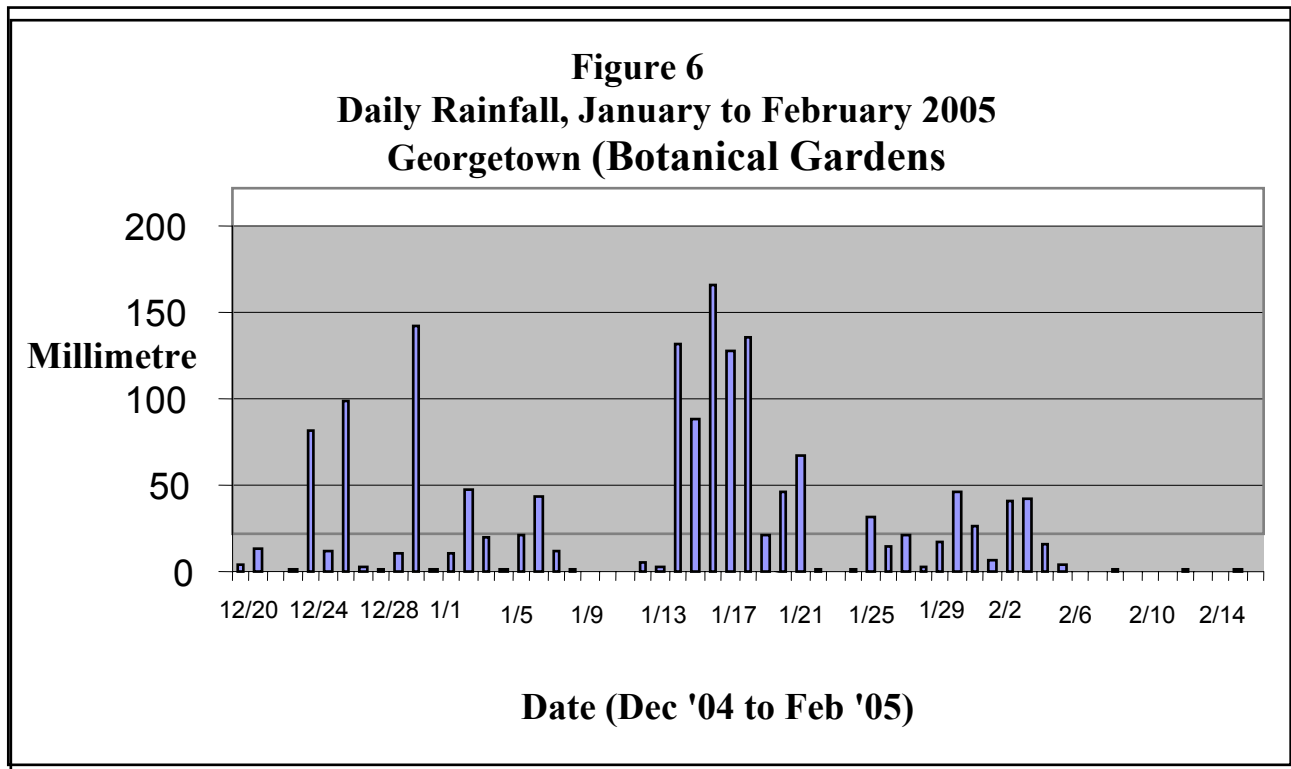
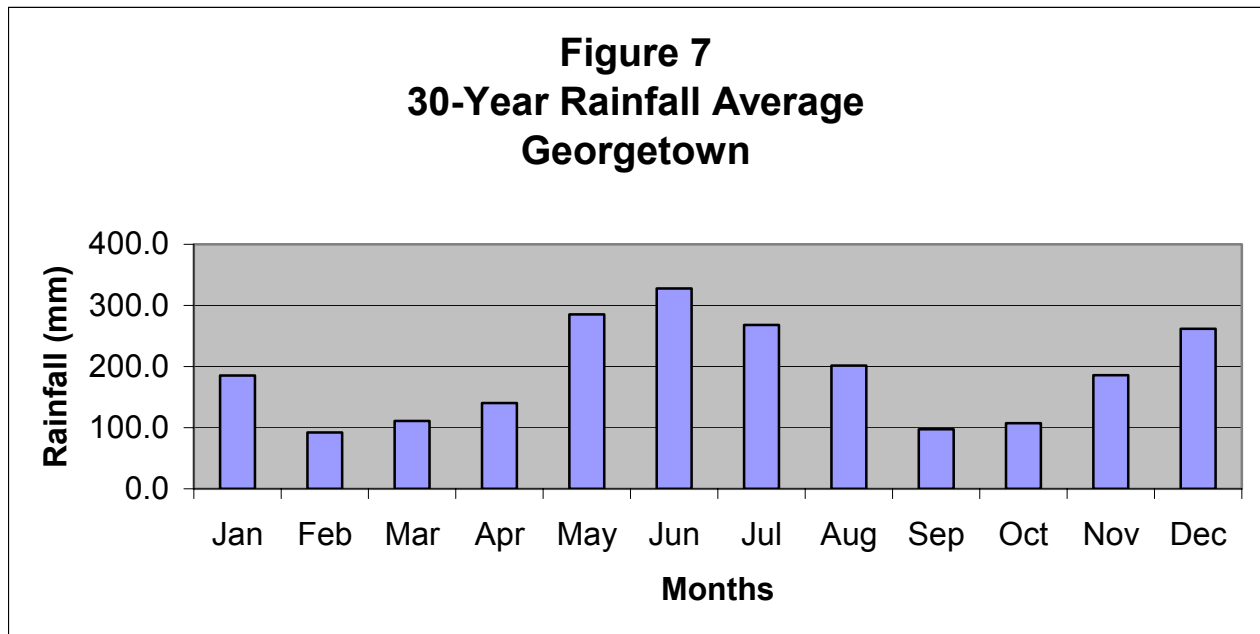
Figure 6 below shows the rainfall data for the Georgetown Botanical Gardens for the period 20 December 2004 to 14 February 2005, while Figure 7 shows the monthly rainfall for January 2005 compared with the 30-year average. January's rainfall at 1108.2 mm was almost six times the 30-year average of 185.2 mm.
