Assessment of the Effects and impacts
Caused by **Hurricane Irma**

The Bahamas

2017

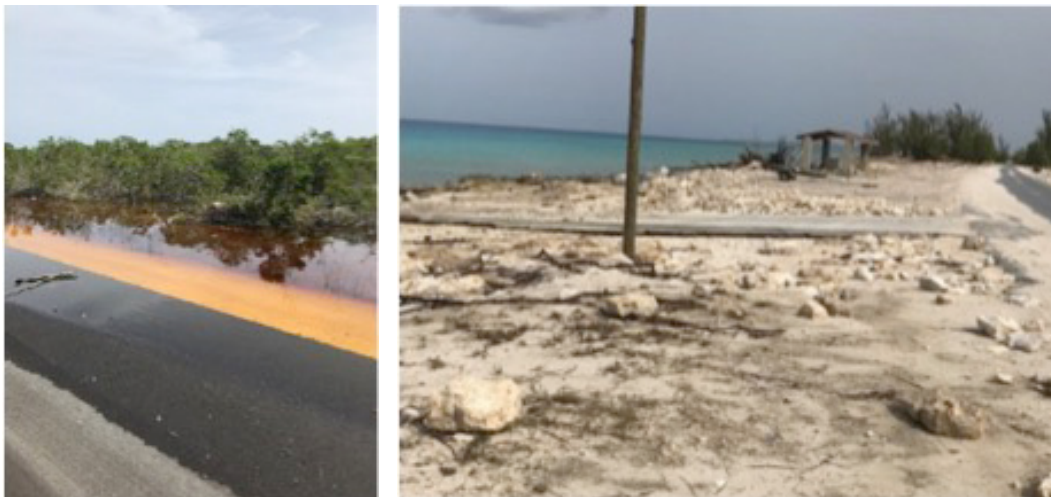
Image 1 - Pavement structure and draining problems, in Acklins and Great Inagua Islands.

- A. Lack of a consistent design and construction standards and methods
- B. Insufficient technical supervision during construction to ensure a correct outcome
- C. Inefficient and low quality structural components and construction deficiencies
- D. Use of inappropriate materials given the local hazards and environment, causing the structure to deteriorate and become unable to withstand the effects of natural events
- E. Absence of proper draining channels and systems to conduct rainfall adequately

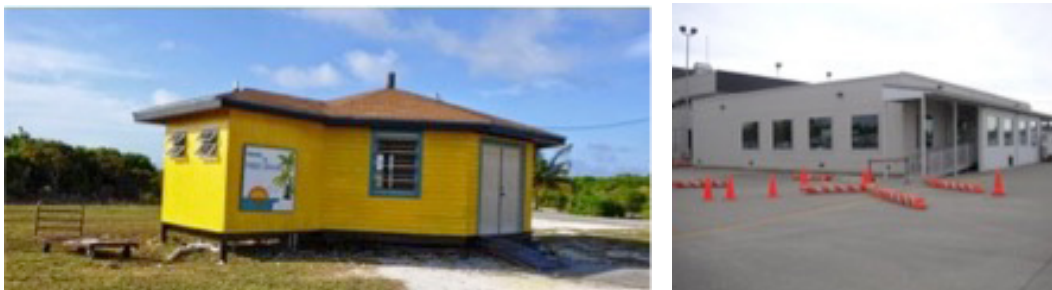
Image 2 - Ragged Island Airport Terminal / Resilient Prefabricated Solution.

Duncan Town Airport on Ragged Island is the only airport facility of the report that suffered damage to its runway and terminal building. It is important to address in this chapter that critical public buildings such as airports, hospitals and schools among other should be subject to more resilient and rigorous design standards in order to provide adequate service to the population but more importantly to support emergency response situations as well as serve a potential shelter and provide a safe evacuation process. In Image 2 we present the Ragged Island terminal building before the storm and a potential resilient solution (prefab building) to support our statement. The next section presents detailed information on the damage and the costs associated to the repairs and reconstruction efforts.

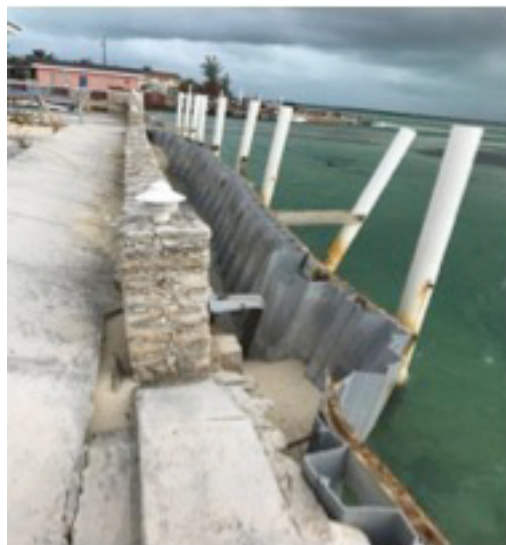
Image 4 - Damage on private dock facility at Bimini

In general, port structures suffered minor damage to pillars and to decks made of concrete slabs for the small fishing docks. Also, as per the assessment team's inspection and interview with one of the private dock managers, the continuous and cyclical sea surge and tide impact caused severe damage in the infrastructure of the Resort World Marina in Bimini. The effects were the result of various aspects: 1) Potential noncompliance with structural criteria (Image 4); 2) Light floating structures that barely support the effects of these type of natural events 3) Construction materials that when damaged can subsequently create an environmental problem (Image 5). These facilities are critical to other important sectors, and should be designed and constructed considering rigorous codes and standards in order to support natural events of this nature, more in accordance with the resilient design observed in Great Inagua dock facilities (Image 6).

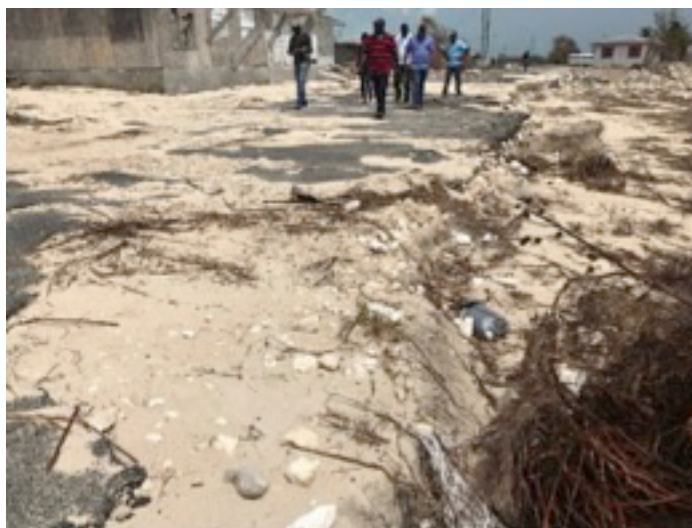
Image 7 - Damage in Roads at Salina Point, Acklins Island

The road network is mainly paved, so most hurricane damage consisted of potholes formed by erosion due to heavy water flow as observed in Salina Point area (see Image 7). The absence of proper drain channels, sidewalk gutters, ditches, gutters and counterdrains generate excess water flow to damage the pavement structure at laterals. This allows water to run without restraint, causing it to reach and residences..

It is important to evaluate areas for the potential for building storm water-retention ponds in strategic areas. Such ponds can regulate the delivery of rainfall to rivers, minimizing the risks of possible floods from excess water. Ideally, a storm water retention pond is designed so that the land vents at least 10 per cent less water flow than if in a normal undeveloped condition. This allows the region to start minimizing the impact of rain entering the river network throughout the country.

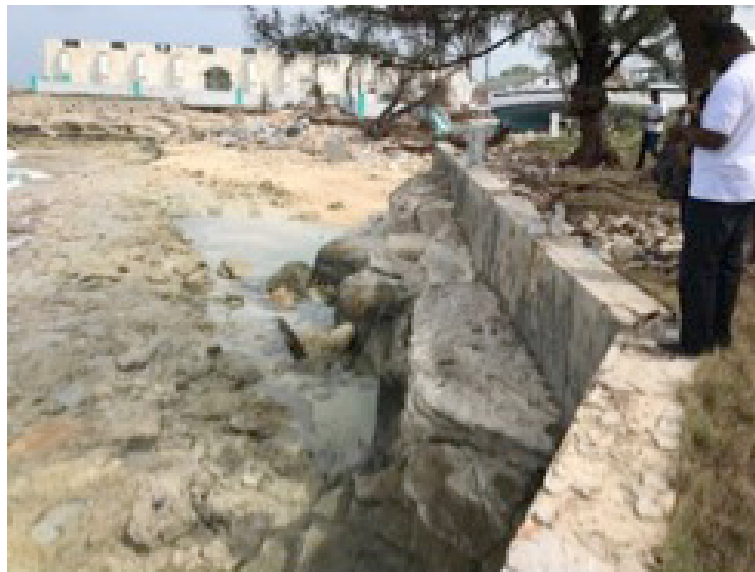
Image 8 - Seawall Damage Inspected in Great Inagua

vertical wall and damage in the structure was observed in addition, other seawall areas were not executed according to the basic design and construction practices for a protection structure of this importance. This was seen as the implementation of temporary solutions to create defensive seawalls, often informally done by accumulating large natural rocks and laying them onto the existing beach material, as well as using non-resilient construction solutions, low quality materials, and the inadequate site construction supervision and inspection (Image 8). This creates an area of weakness in the shoreline by exposing the population to a non-resistant solution.

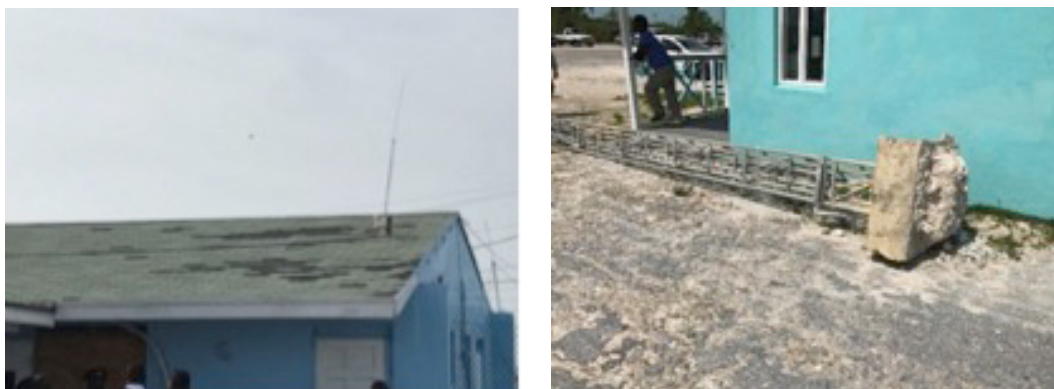
Image 10 - Minor Damage at Great Inagua and Acklins Islands Airports

Airport buildings sustained some roof damage, antenna and small sections of fencing were affected at the Great Inagua and Acklins Islands airports (Image 10). The Ragged Island airport building structure entirely collapsed due the force of Hurricane Irma wind forces (Image 11). It is important to point out that light structure construction and the apparent lack of improvements or maintenance creates a strategic facility extremely susceptible to natural events, and risks being disconnected to other sectors.

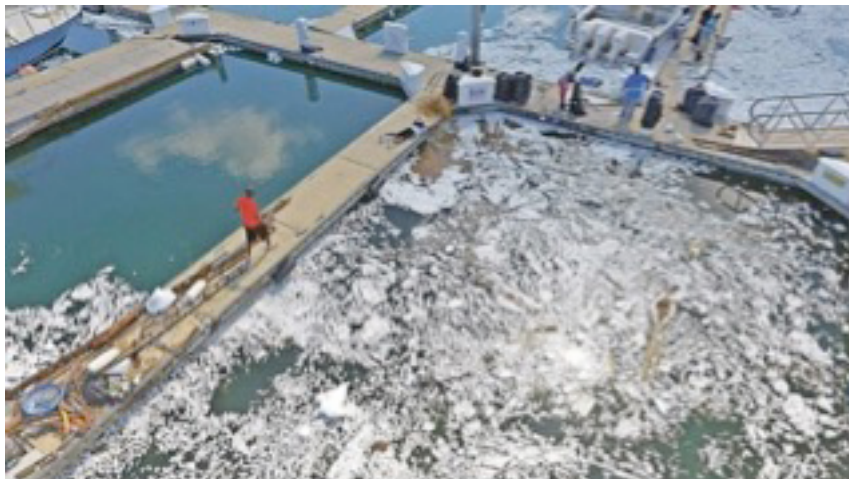
Image 13 - Styrofoam floating in the ocean in Bimini in September

On Bimini the Resort the World Marina was damaged. This affected the beaches and the surrounding environment due to the degradation and subsequent spreading of materials such as polystyrene foam in the surrounding waters (Image 13). Special considerations and evaluations of the reconstruction process should be taken to mitigate the risk of this situation in potential future events.

In the specific case of floating docks, there was environmental damage in Bimini as a result of the breakup of poly-styrene flotation material that was released into the marine ecosystem when the docks were destroyed by heavy waves. There should be regulation put in place to ensure that this type of design is not used in areas exposed to potential heavy wave action. Additionally, it would be appropriate to redesign this type of dock such that, in the event that it does get destroyed, the flotation material would be released as large, self-contained chunks that could be collected, without the release of tiny plastic pellets that are almost impossible to contain.

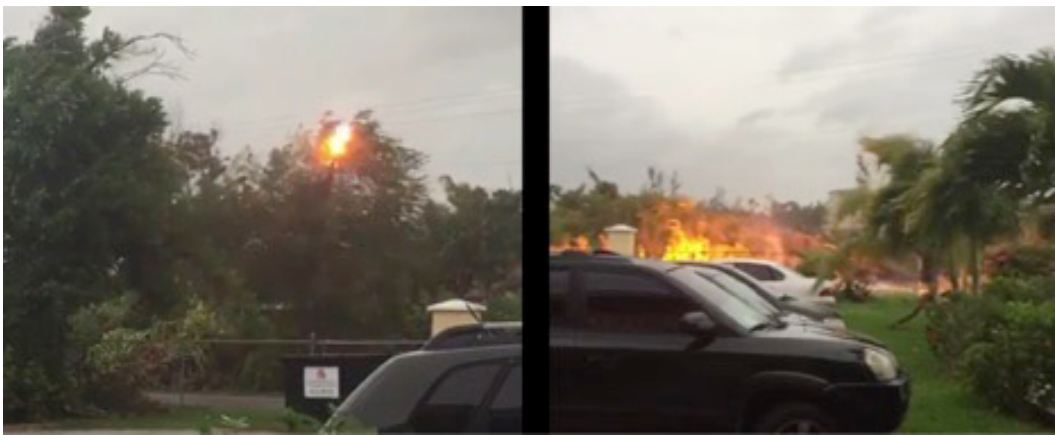
Image 14 - Brush fire caused by contact between vegetation and power lines

There was also at least one fire caused by electricity on Grand Bahama, (Image 14) where a brush fire was caused when conductor cables oscillating in the wind came in contact with the top branches of a nearby tree. This occurred on the afternoon of 10 September, the same day tornados touched down on the island. Nearly 50 poles on the island were damaged, mostly as a result of tornados, and around 10 PM the power grid shut down to protect itself from damage, sending Grand Bahama into a blackout. Unlike BPL in some of the southern islands, GBPC had opted not to perform a controlled shutdown prior to the storm. The island was 99 per cent re-energized within five days after the storm, though there was an additional delay caused by the need to rinse salt spray off of transmission lines and substation equipment.

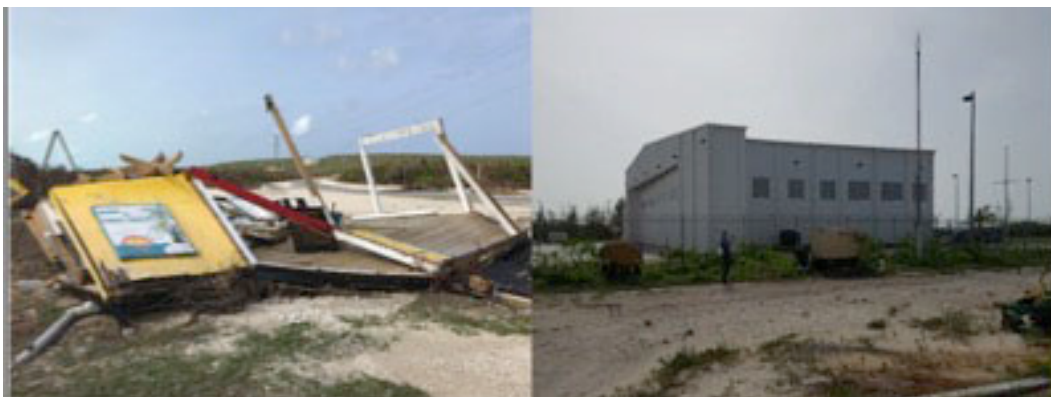
Other examples of robust and resilient design failures and successes were assessed in Ragged Island. There, the storm surge completely devastated the airport terminal. This situation contrasts with the robust design of the US Coast Guard Aviation Facility in Great Inagua (Image 18). By using resilient designs and adequate construction materials the probability of damage of these important and strategic assets can be considerably reduced.
