A SUSTAINABLE AND INTEGRATED BUILDING RENOVATION

A United Nations Earthquake Recovery Initiative in Chile

Published February 2015

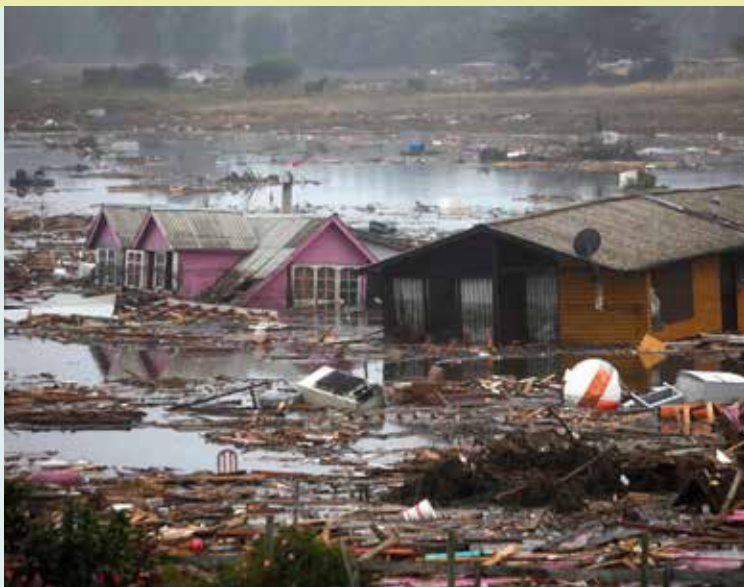
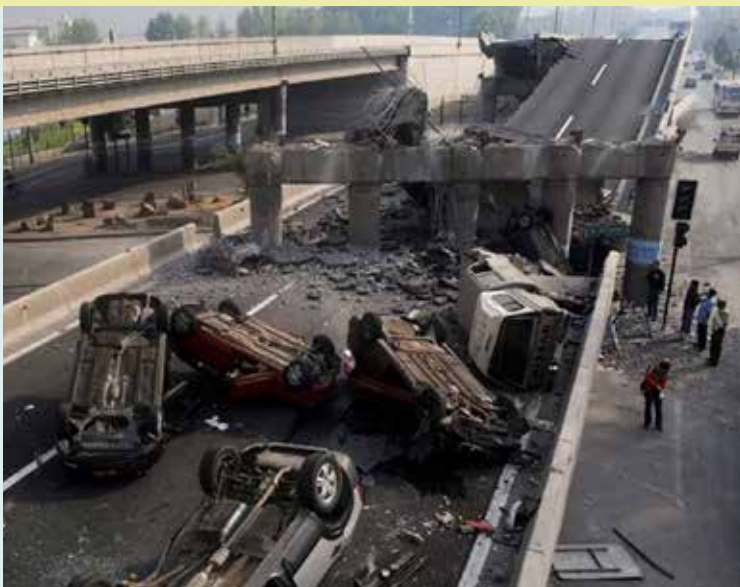
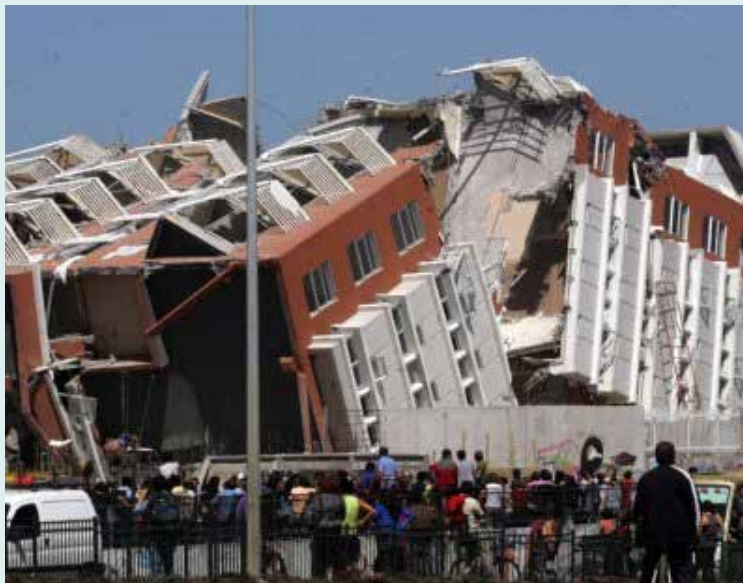
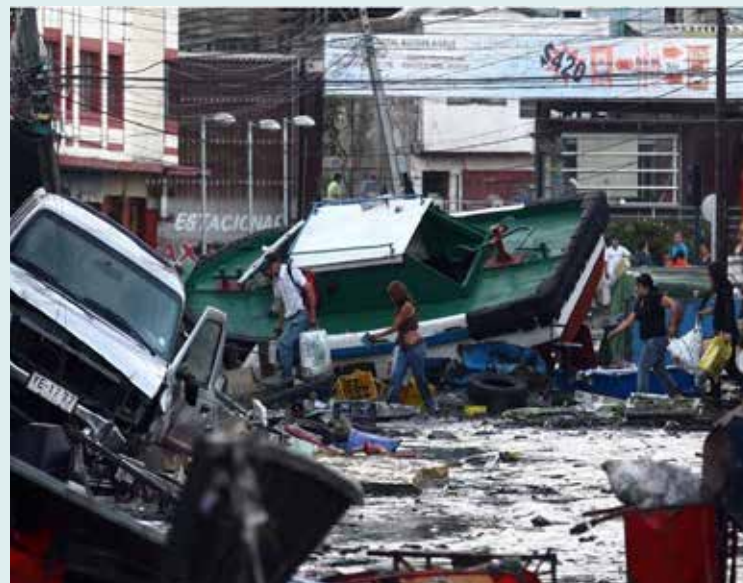
The earthquake was felt strongly in six Chilean regions (from Valparaíso in the north to Araucanía in the south), that together make up about 80 percent of the country's population. According to the United States Geological Survey (USGS) the cities experiencing the strongest shaking—VIII (Destructive) on the Mercalli intensity scale (MM)—were Arauco and Coronel. According to Chile's Seismological Service, Concepción experienced the strongest shaking at MM IX (Violent). The earthquake was felt in the capital city of Santiago at MM VII (Very Strong) or MM VIII. Tremors were felt in many Argentine cities, including Buenos Aires, Córdoba, Mendoza and La Rioja. Tremors were felt as far north as the city of Ica in southern Peru (approx. 2400 km). The earthquake triggered a tsunami which devastated several coastal towns in south-central Chile and damaged the port at Talcahuano. Tsunami warnings were issued in 53 countries, and the wave caused minor damage in the San Diego area of California as well as the Thoku region of Japan, where damage to the fisheries business was estimated at ¥6.26 billion (USD \$66.7 million). The earthquake also generated a blackout that affected 93 percent of the country's population and which went on for several days in some locations.

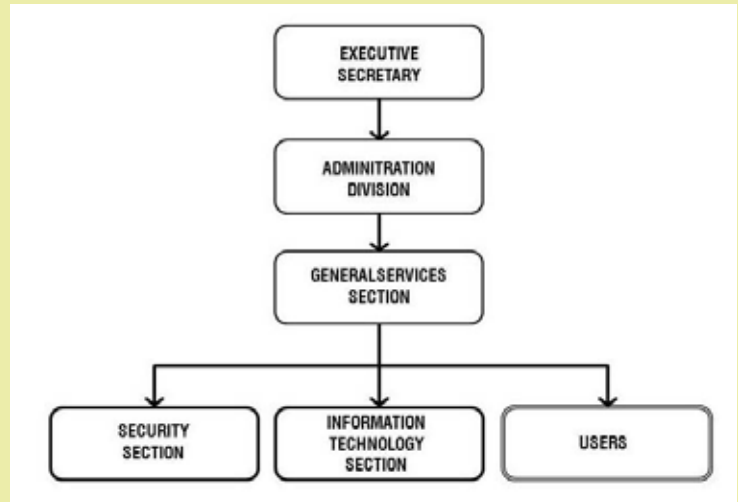
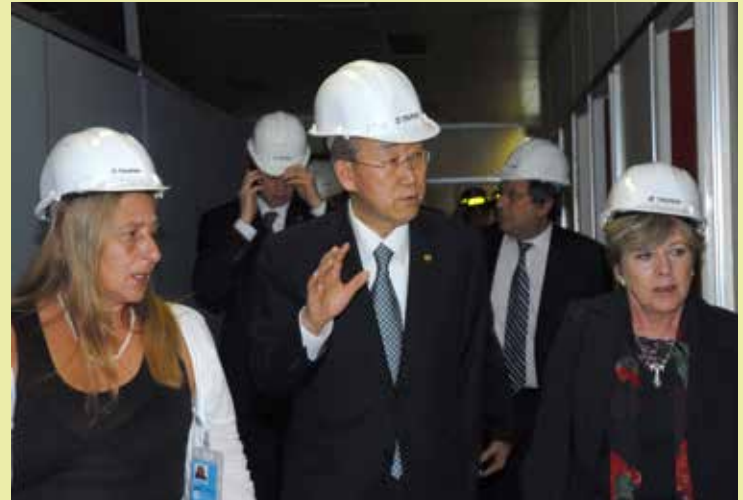
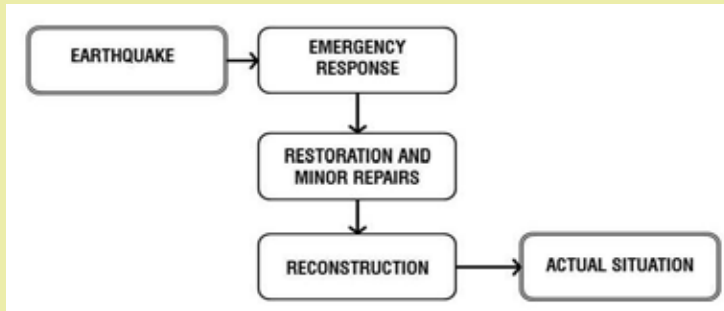
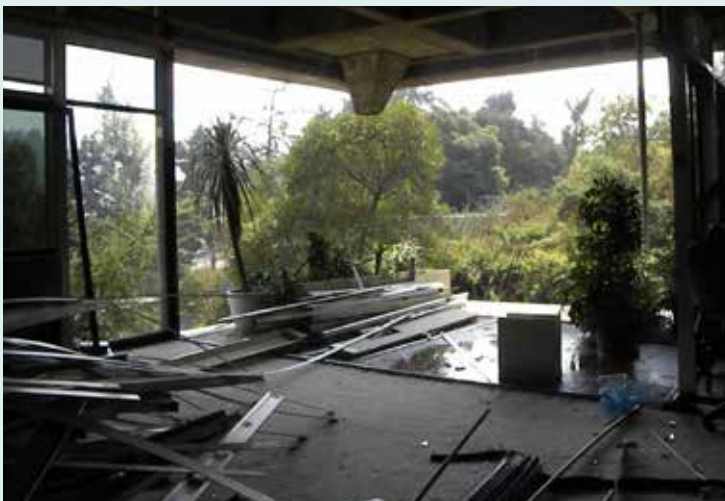
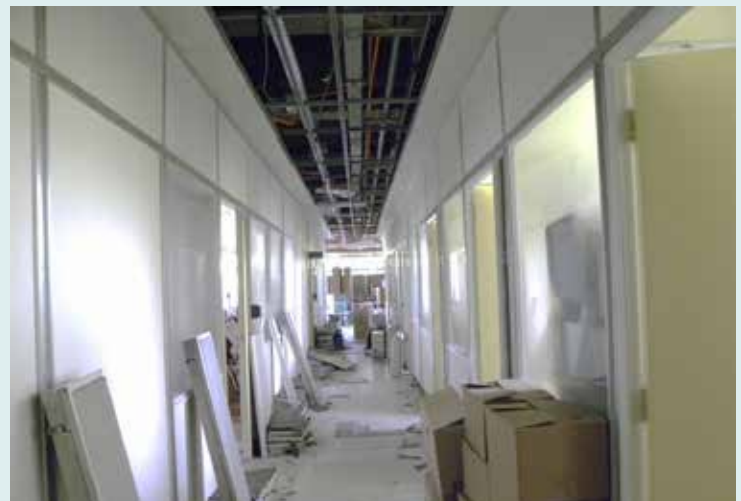
EMERGENCY RESPONSE (Business Continuity Plan): In this initial phase the main objective was to re-establish normal operations of ECLAC as quickly as possible and to prepare activities for the following two stages. Main activities were space habilitation and debris removal. It was necessary to clean up and remove debris from usable workspace. Some loose parts and stucco from affected buildings required demolition, cleaning, and debris removal. In parallel, a thorough damage assessment work was performed not only by ECLAC's engineering team but also by external consultants. The assessment consisted of: structural evaluation from three independent structural engineers; diagnosis and space usability evaluation; and infrastructure inspection and utilities evaluation. Along with the previous, some urgent repairs were performed by both internal staff and external companies. Last but not least, an insurance notice was emitted and insurance claim filed. During this phase a complete space reallocation and workspace re-assignment was performed, including computer and furniture moves, storage of damaged assets, and storage of staff personal belongings. This stage also included several associated bidding processes for food services including the implementation of a temporary cafeteria in a tent, rental of a prefabricated office building, reconstruction of meeting rooms, and procurement of containers for temporary storage.

RESTORATION (Minor Repairs): At this stage the emergency was controlled and operations at ECLAC stabilized, but 30% of existing workspace was unusable. Facilities Management Staff resumed normal work procedures and started scheduling and prioritizing the incoming projects associated with this phase. Major objectives were to execute minor repairs to habilitate workspace. Disassembly and demolition of damaged areas were executed, including Fajnzylber auditorium, the main working floor, and four staircases located at the main building, along with execution of structural repairs to damaged areas. In addition, the window system in the first floor that sustained serious damage was replaced. The temporary cafeteria was implemented and started providing food services and the temporary office building was installed on an open parking area and began to be used as swing space to move staff during renovation of workspace. Several containers were installed to provide temporary storage rooms. Associated bidding processes included execution of the demolition work related to Fajnzylber auditorium and main building workspace, including the replacement of HVAC equipment and the provision of an energy efficient façade. Architecture and engineering staff started the development of the new cafeteria project.

RECONSTRUCTION (Construction projects): This stage was the final step to recover pre-earthquake conditions and consisted of all major construction projects to be executed including complete reconstruction of the main working floor at ECLAC, which represents one third of the total office space. In addition a new building for food services was executed. The complete project including architecture and engineering was developed internally by ECLAC staff. A special emphasis was given to the fourth floor Fajnzylber Auditorium. Due to the patrimonial condition of the building and the understanding that our building is an icon of Latin American Modern Architecture, the Committee for Documentation and Conservation of Buildings, Sites and Neighborhoods of the Modern Movement (DOCOMOMO) expressed its interest to the United Nations ECLAC in participating in the renovation works by calling for an academic forum – a seminar – that allowed for a gathering of innovative and informed project ideas. This cooperation between ECLAC, the DOCOMOMO International and DOCOMOMO Chile was agreed as an academic venture established as a central experience within the field of the modern heritage intervention. The seminar resulted in an international call for ideas where three projects were selected out of fifteen presented. The final selection was awarded to a local architecture firm and executed accordingly.

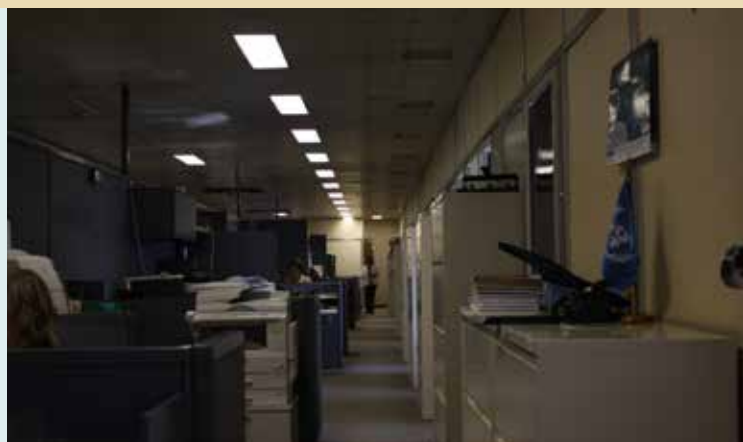
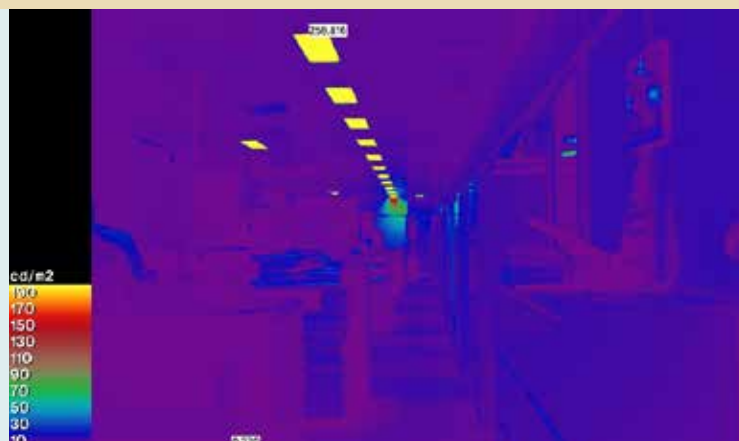
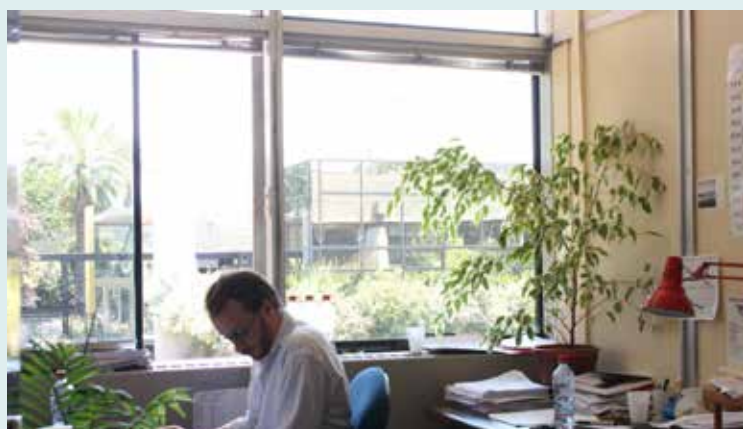
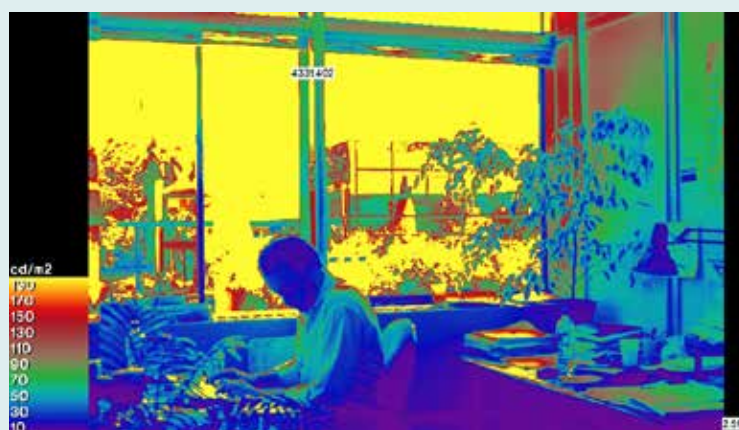
HDR IMAGES ANALYSIS

The HDR images analysis presented some typical luminance situations in a west wing office, a north wing office and an interior open plan office. These situations are most representative of the original building luminance situation.

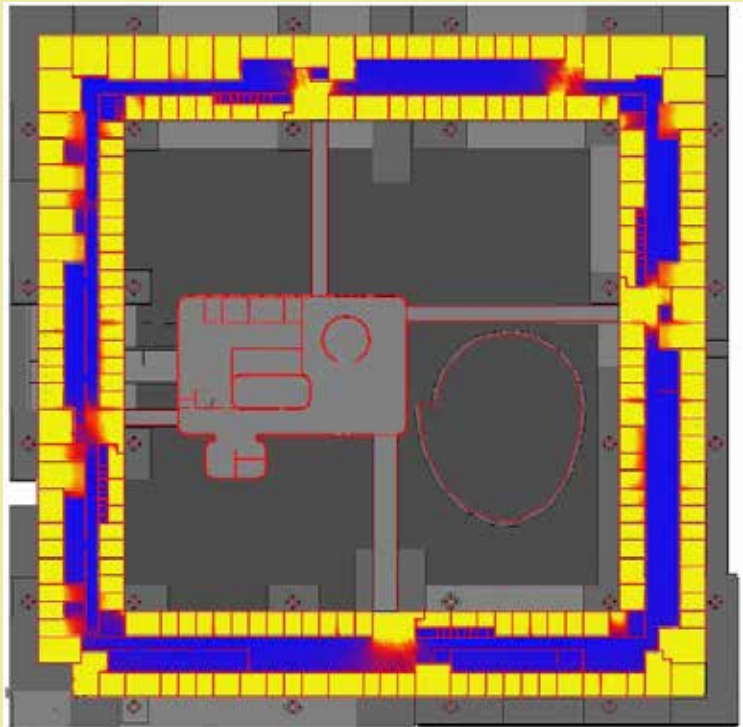
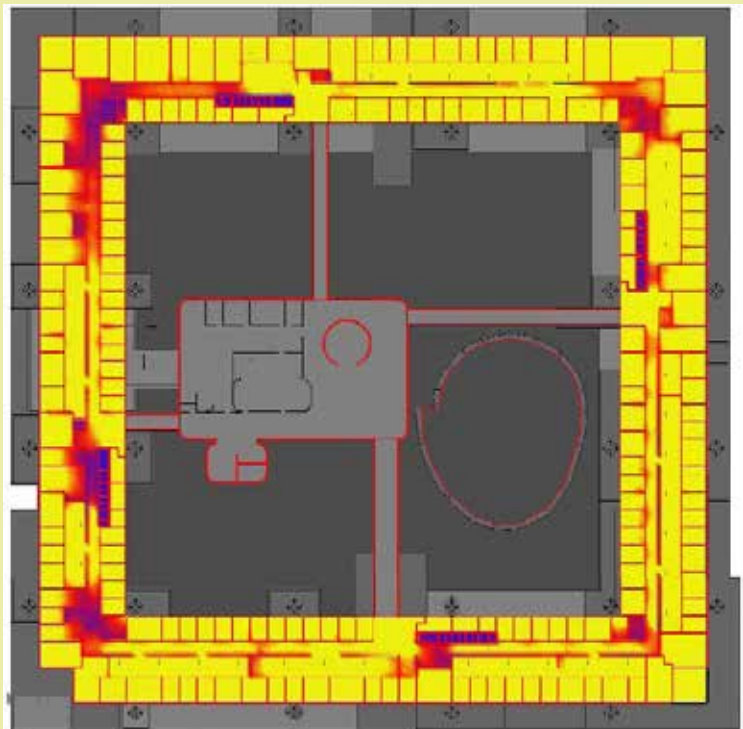
Daylight Availability: Illuminance Levels Simulations

The image shows the baseline building illuminance floor plan with a 0 - 280 lux scale. It shows minimum LEED requirements fulfilment on the perimeter cellular offices. Nevertheless, the internal open plan offices illuminance levels were not sufficient to meet the minimum LEED daylight requirements. A daylight optimization was required to increase the internal open plan offices; Solatube® incorporation strategy ensures LEED minimum illuminance levels. Nevertheless, circulation areas where Solatubes® were not installed may require artificial lighting throughout the entire year. Due to the fact that the corridors are not usually occupied spaces, is not critical but desirable to have daylight in such spaces to increase the environmental quality and

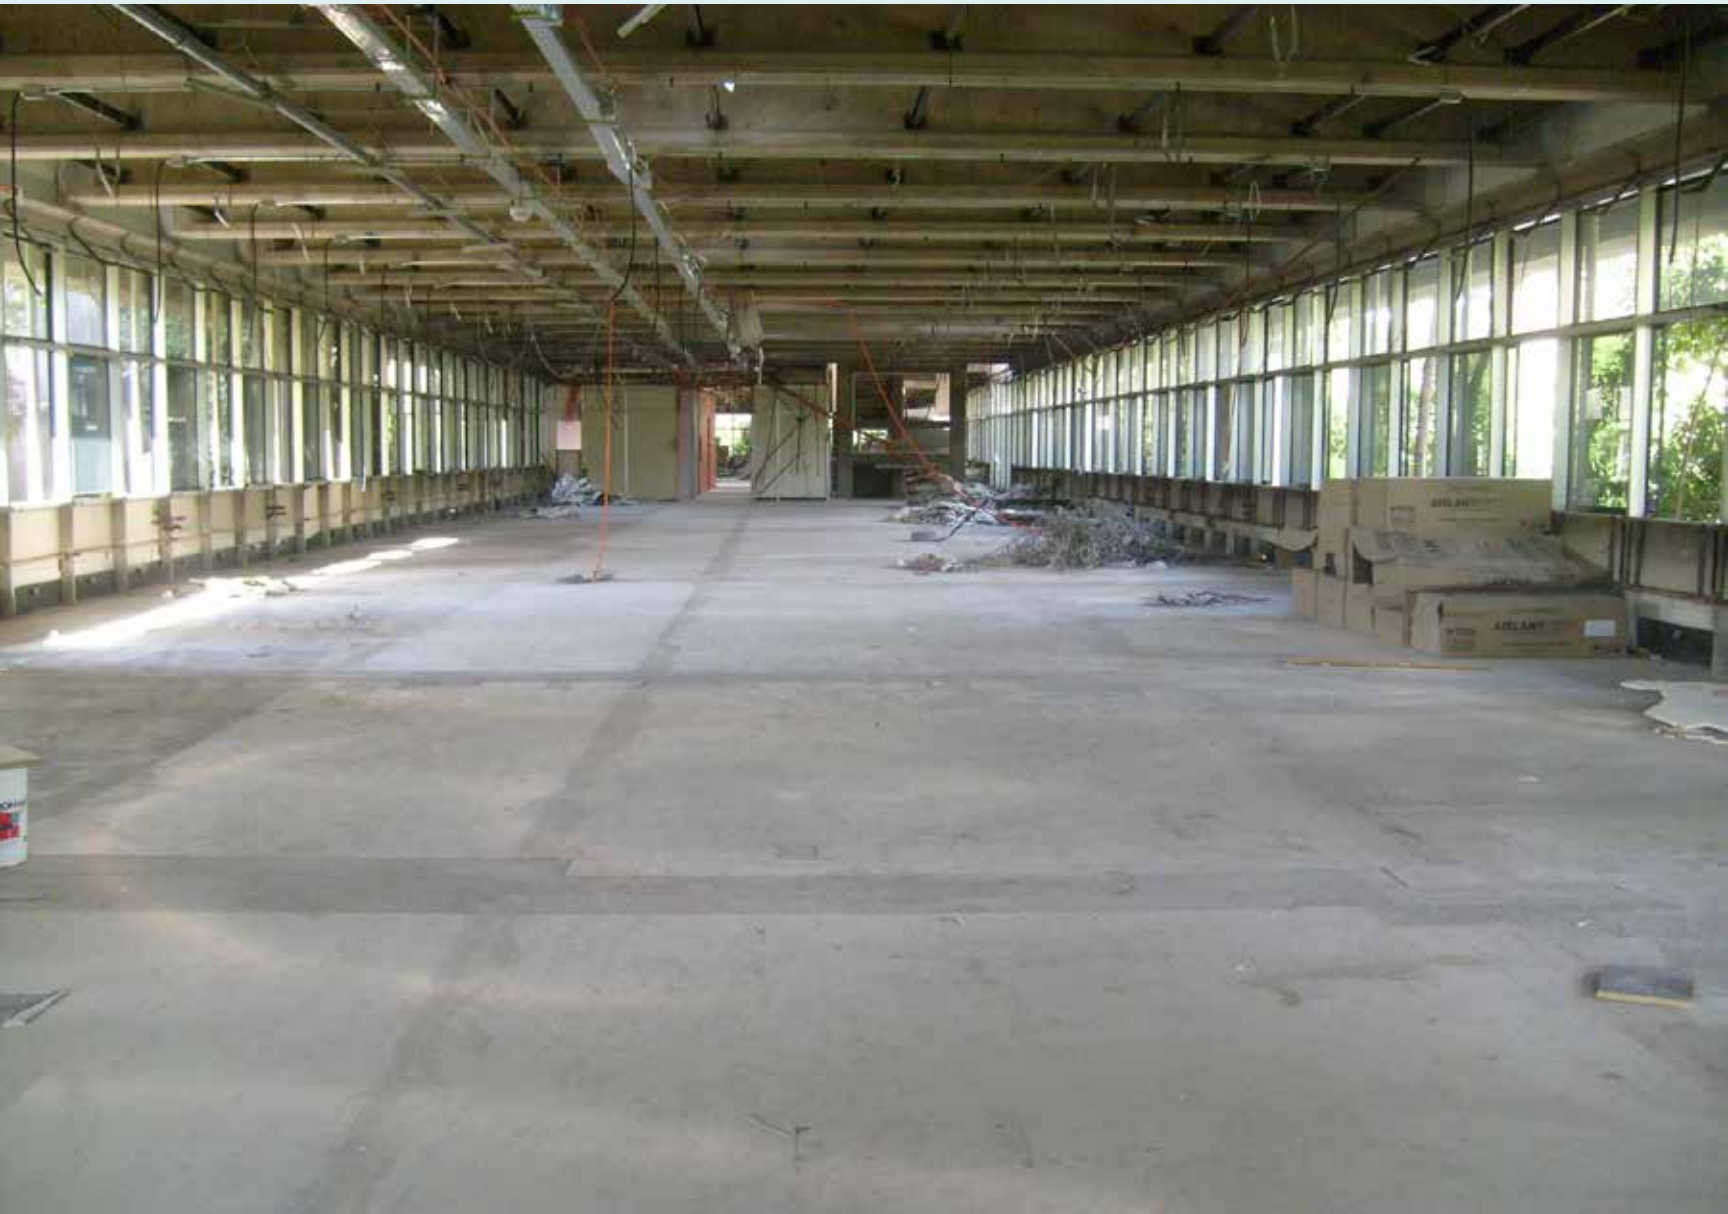
Due major damage after the earthquake all furniture, interior partitions, windows, ceilings, illumination and HVAC systems, electrical installations, network and telephone lines, as well as pavement and carpets where dismantled.

No interior elements remained and original structure was cleaned up with posterior elements allowing for a full structural assessment and repair process.

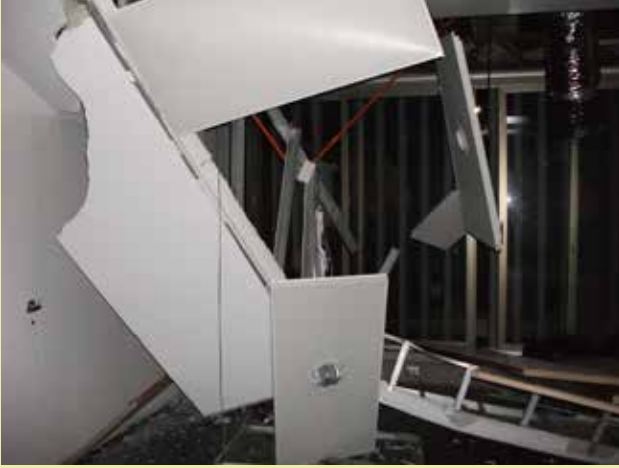
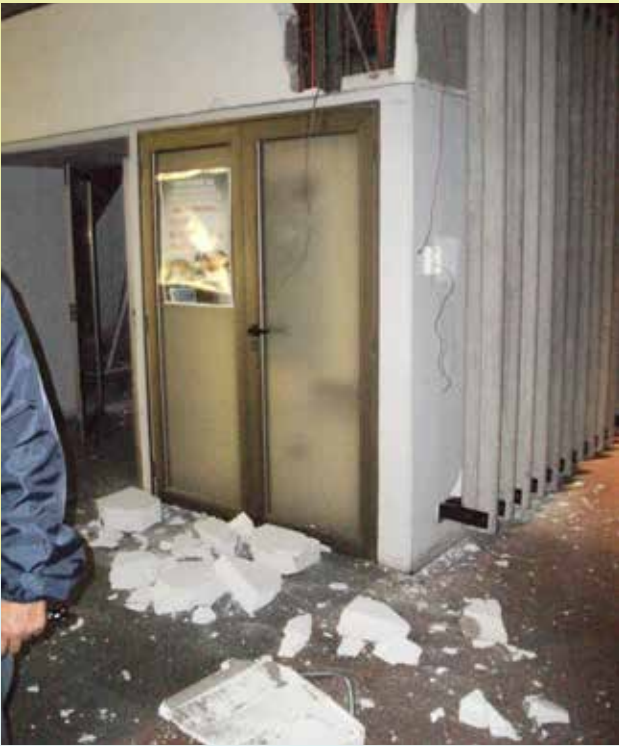
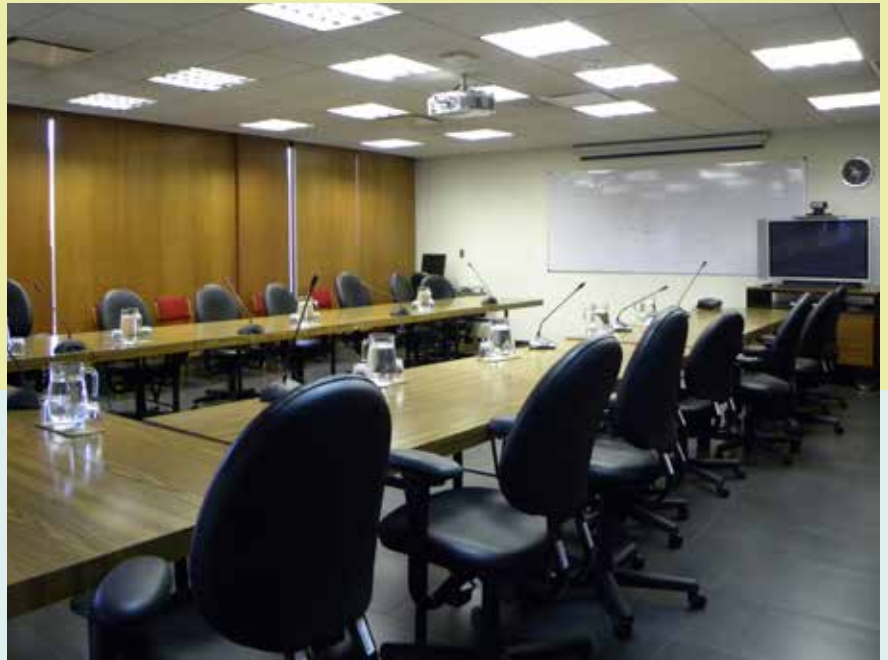
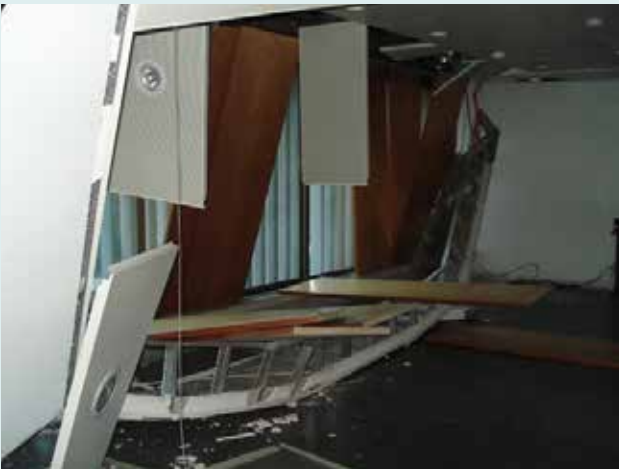
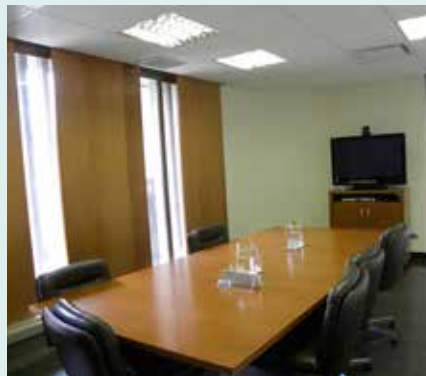
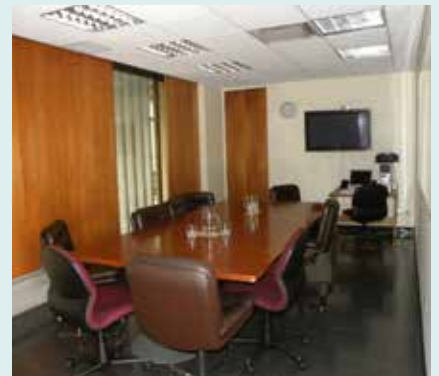
MEETING ROOMS RECONSTRUCTION

The conference rooms located on the ground floor were severely damaged, necessitating their complete reconstruction. Cellular concrete walls were replaced by higher seismic resistance dry walls. Installation of a modular acoustic ceiling with higher resistance to movement and an independent structural system from the floor above makes these spaces resistant to a high magnitude earthquake.

Acoustic insulation of rooms was improved by installing insulating membranes inside walls, allowing their use as videoconference rooms.

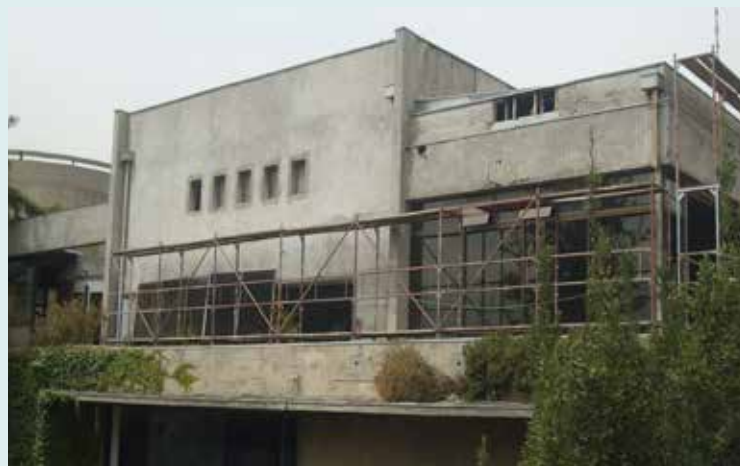
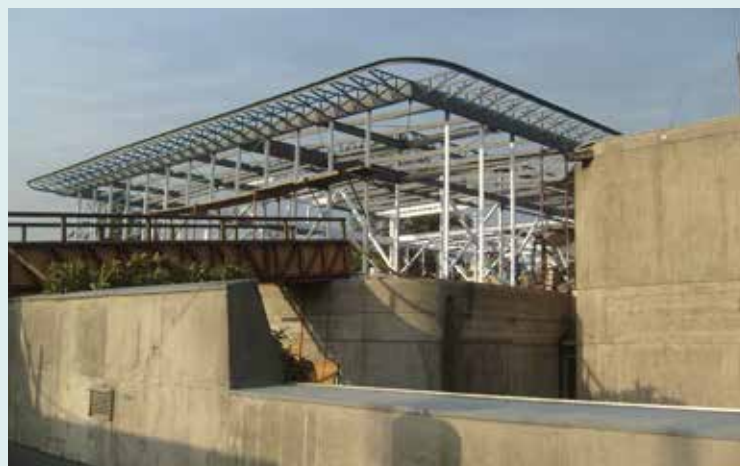
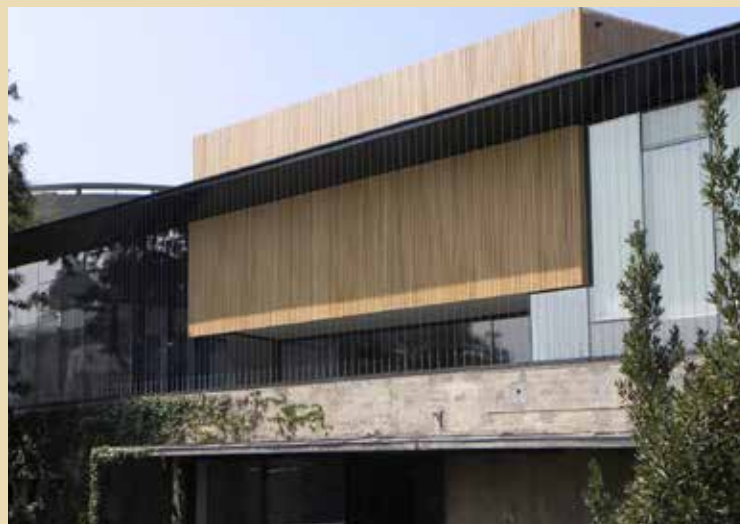
CONFERENCE ROOM RECONSTRUCTION

The conference room on the fourth floor suffered major structural damage during the 2010 earthquake, making necessary its complete demolition and reconstruction.

The reconstruction project was the result of an architectural competition organized by DOCOMOMO, resulting in an architectural project which uses a simple geometry, high transparency and defined geometric volumes, making a respectful solution to the original building, but maintaining a clear separation between the two complementary architectural works.
